City of Waseca Downtown Preservation Design Guidelines

Prepared for
The City of Waseca and the Waseca Heritage Preservation Commission

Prepared by
Thomas R Zahn & Associates LLC
Spring 2014

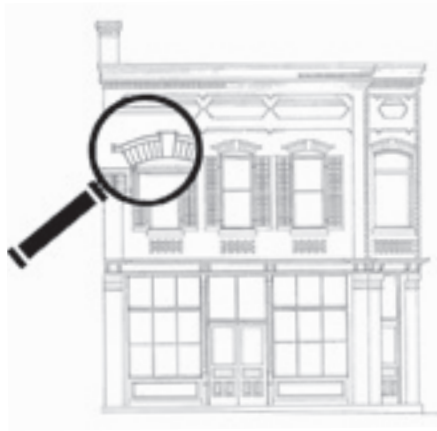
Altered and in need
of maintenance

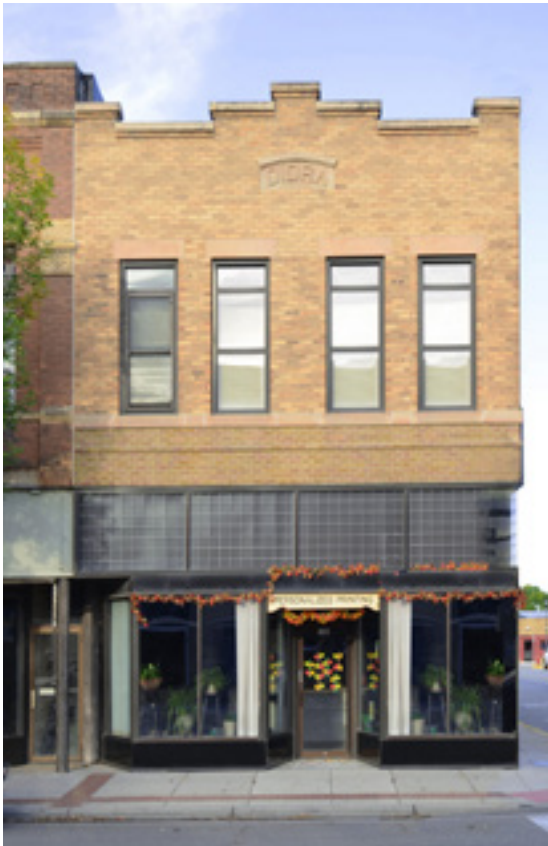
100 State Street South Storefront

The most important feature of Waseca's commercial buildings is the storefront. An emphasis on transparency is created by the use of thin structural members framing sheets of plate glass. Below the display windows are base panels called bulkheads that are made of stone, wood or metal. The entry doors were either recessed or flush with the front facade. Recessed entries provide cover and prevent disturbance of sidewalk traffic. The recessed door also visually draws customers into the building. Often above the entry door and the display windows, and separated by a structural member, is the transom. The transom allows natural light into the store, which originally did not have sufficient artificial light.

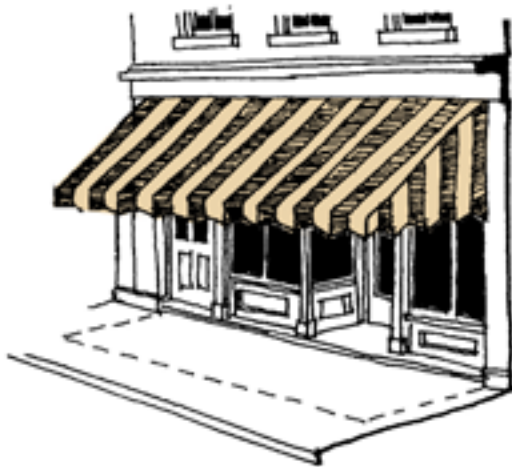
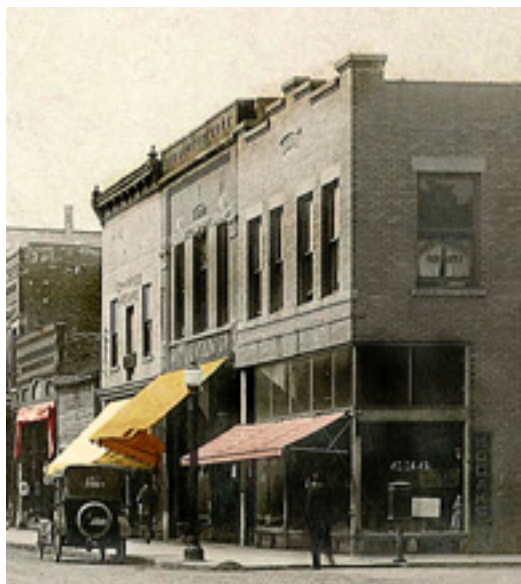
Awnings have been used since the 19th century for storefronts in Waseca's commercial district.

The application of new fabric awnings is encouraged where appropriate.

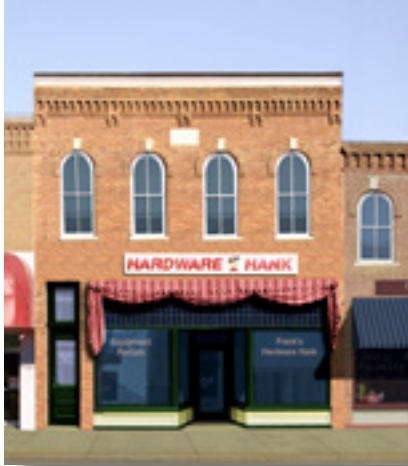
Flat signboards, low-profile projecting signs, painted lettering on the display windows and awning valance are appropriate.

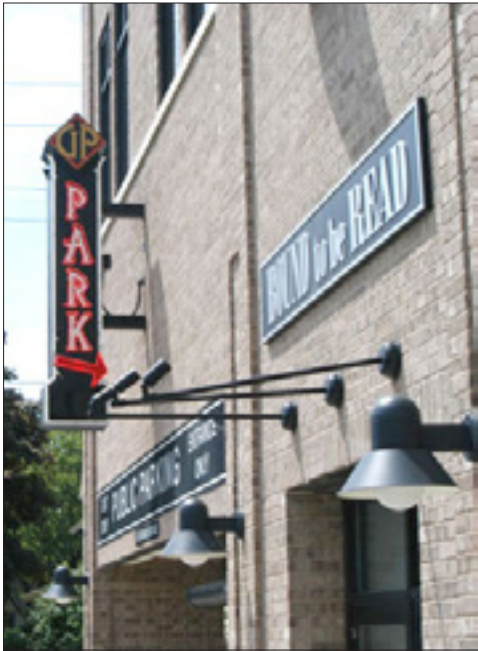
While neon lighting is generally discouraged, if applied on a well-designed, low-profile sign, it may be permitted.

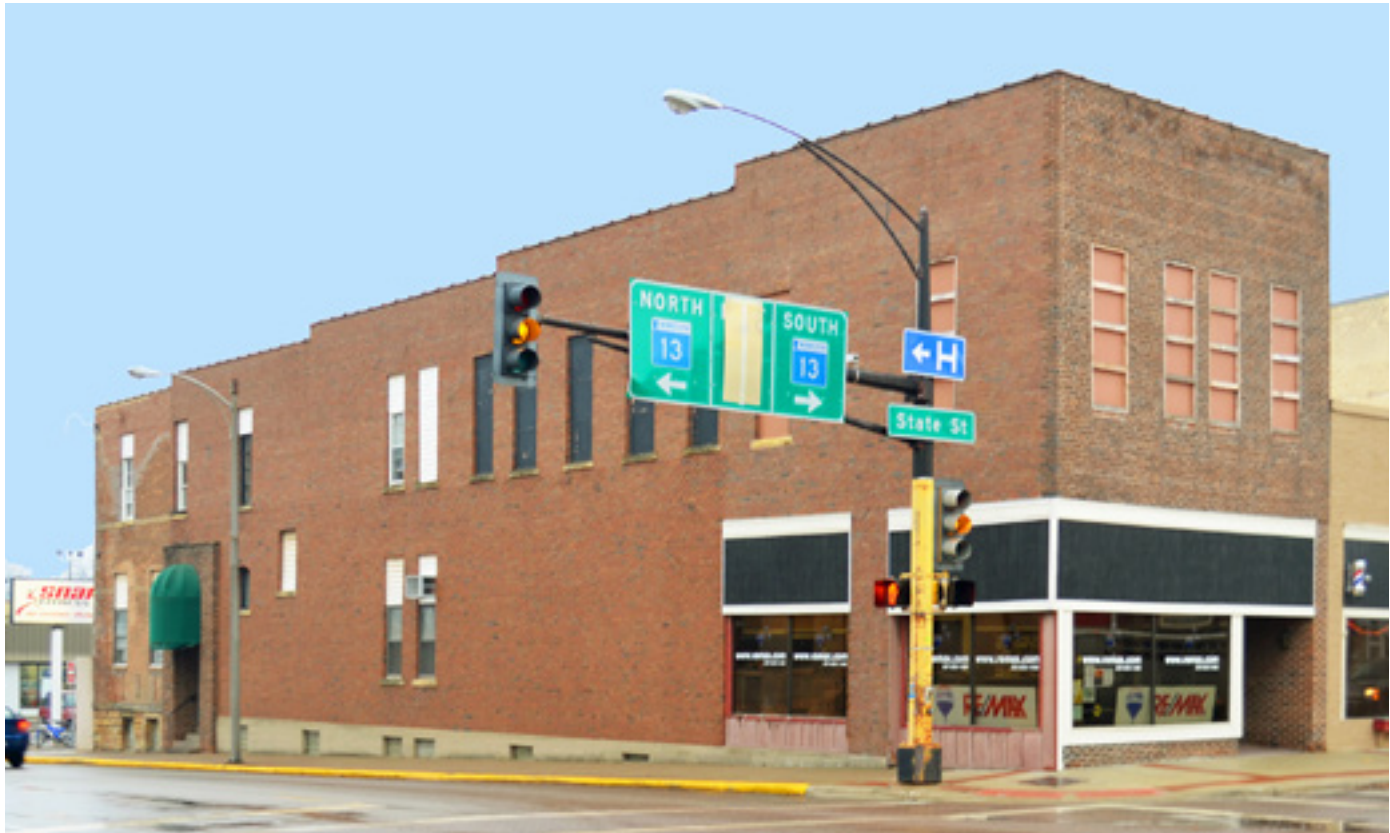
1939 newspaper clipping showing the new elevations of the Pfaffs Building.

- Inspect roofing, coping and flashing are repair where necessary.
 - Clean and repoint brick as necessary.
 - Remove infill panels and insulated, double-hung windows should be installed on the major elevations.
 - Apply appropriate signage over the transom windows.
 - Uncover transom area above display windows and install appropriate transom windows.
 - Hang canvas awnings over corner display windows.

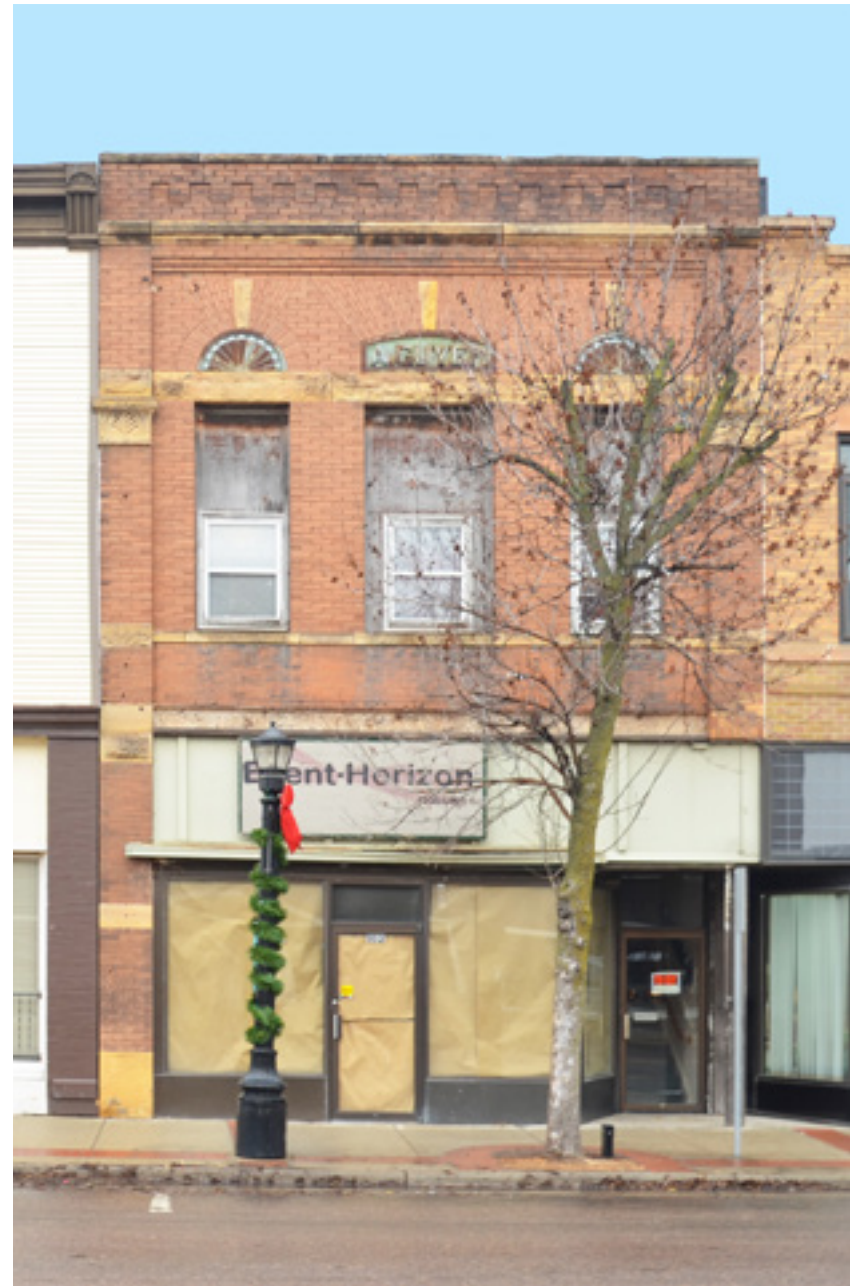
The brick, stone, and copper accents are in need of cleaning and possibly some repair. The building has lost its brick pier support at its northerly corner.

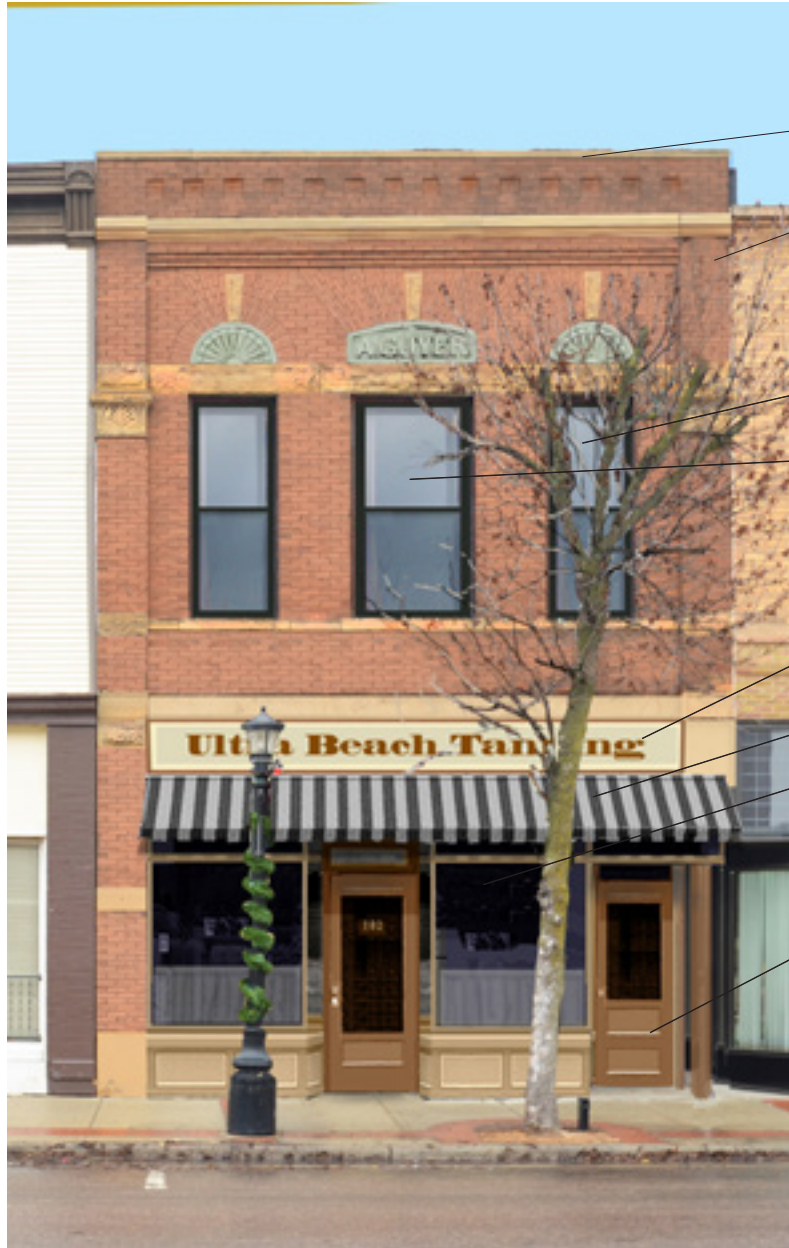
102 State Street South

While the building retains most of its design identifying features, the upper-story windows have been downsized dramatically, the transom has been paneled over, and the turn-of-the-century storefront has been replaced with a modern, aluminum-framed store and stair entry system. The modern installation may have caused the removal of the building's northerly brick and stone pier.

- Inspect roofing, coping and flashing.
- Clean brick, stone and copper insert plates and repoint brick as necessary.
- Remove infill panels and small infill windows on the upper level.
- Install appropriate sized, insulated double-hung windows in upper level.
- Place signage on signboard above the storefront.
- Hang canvas awnings over display windows.
- Remove modern aluminum storefront and install appropriately designed large display windows with bulkheads below.
- Replace modern aluminum frame doors with wood and glass door set as originally designed.

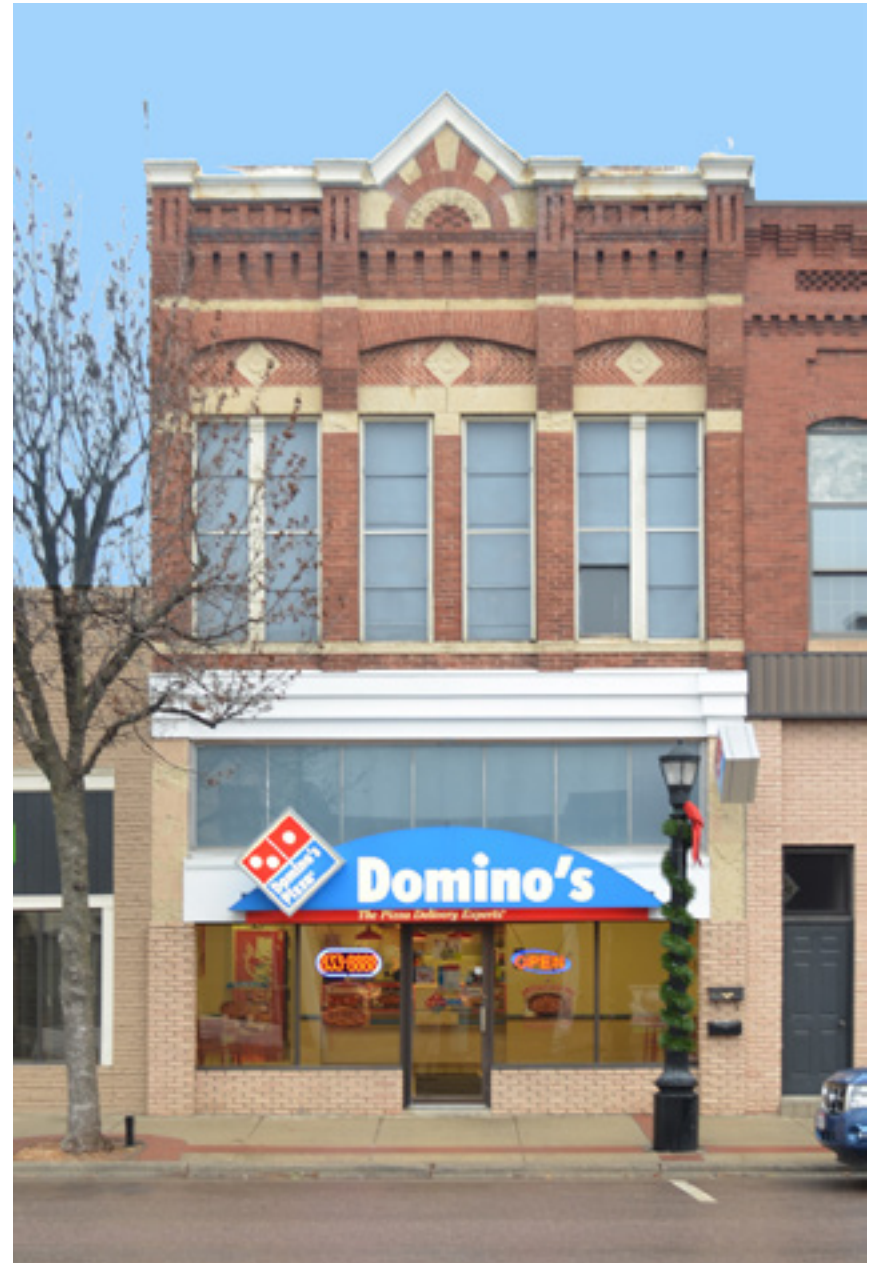
The storefront opening has been framed in a cream-colored brick veneer. The storefront displays translucent panels over a modern anodized aluminum framed glass front with a centered entry. Above the entry is a exuberant commercial signage.

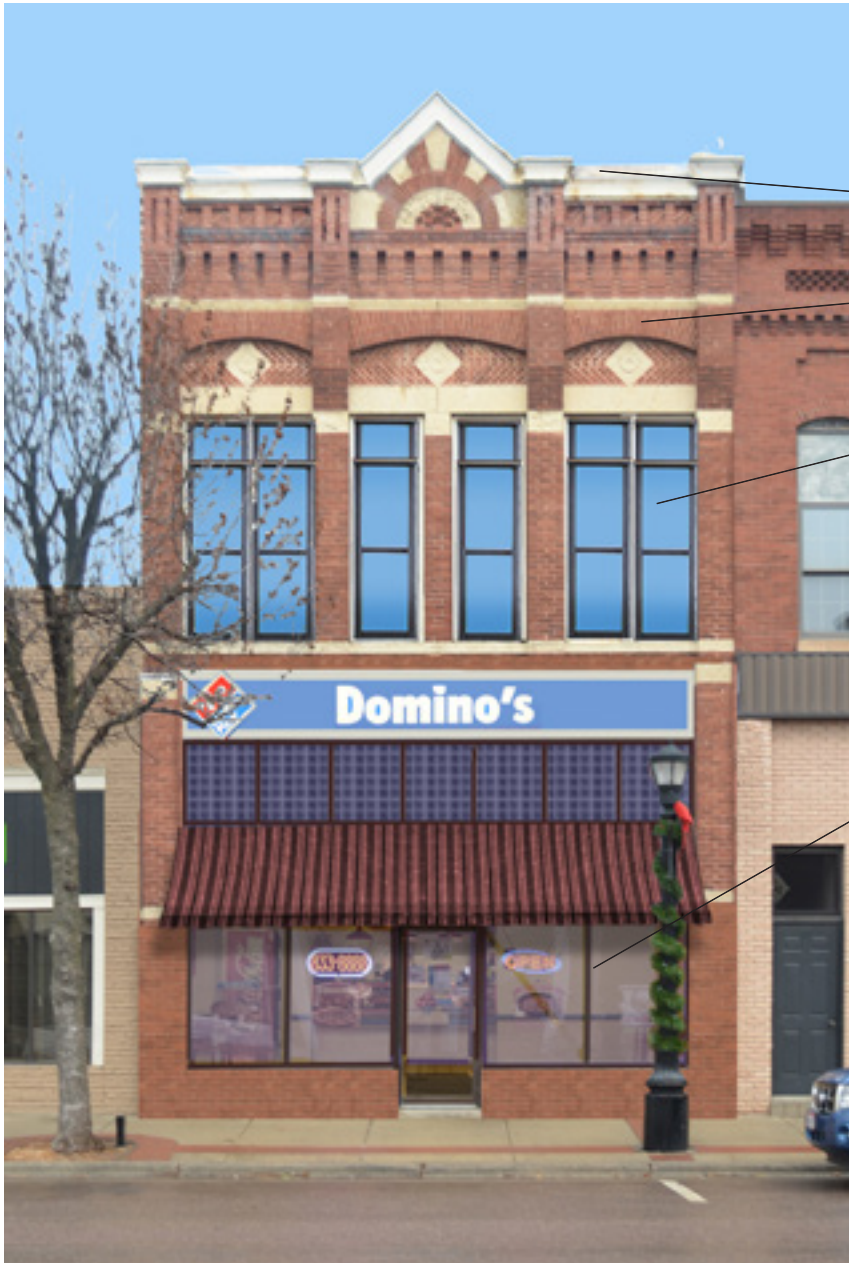
- Inspect roofing, coping and flashing.
- Repair, clean and repaint the cornice as necessary.
- Clean the stone and brick and repoint as needed.
- Remove panels from upper window openings and install insulated double-hung windows to size.
- Place commercial signage on a signboard above the storefront opening.
- Consider removing the cream brick veneer and determining if the original red brick is intact in the piers.
- The transom opening should display appropriate glass infill and support a retractable canvas awning above the entry.

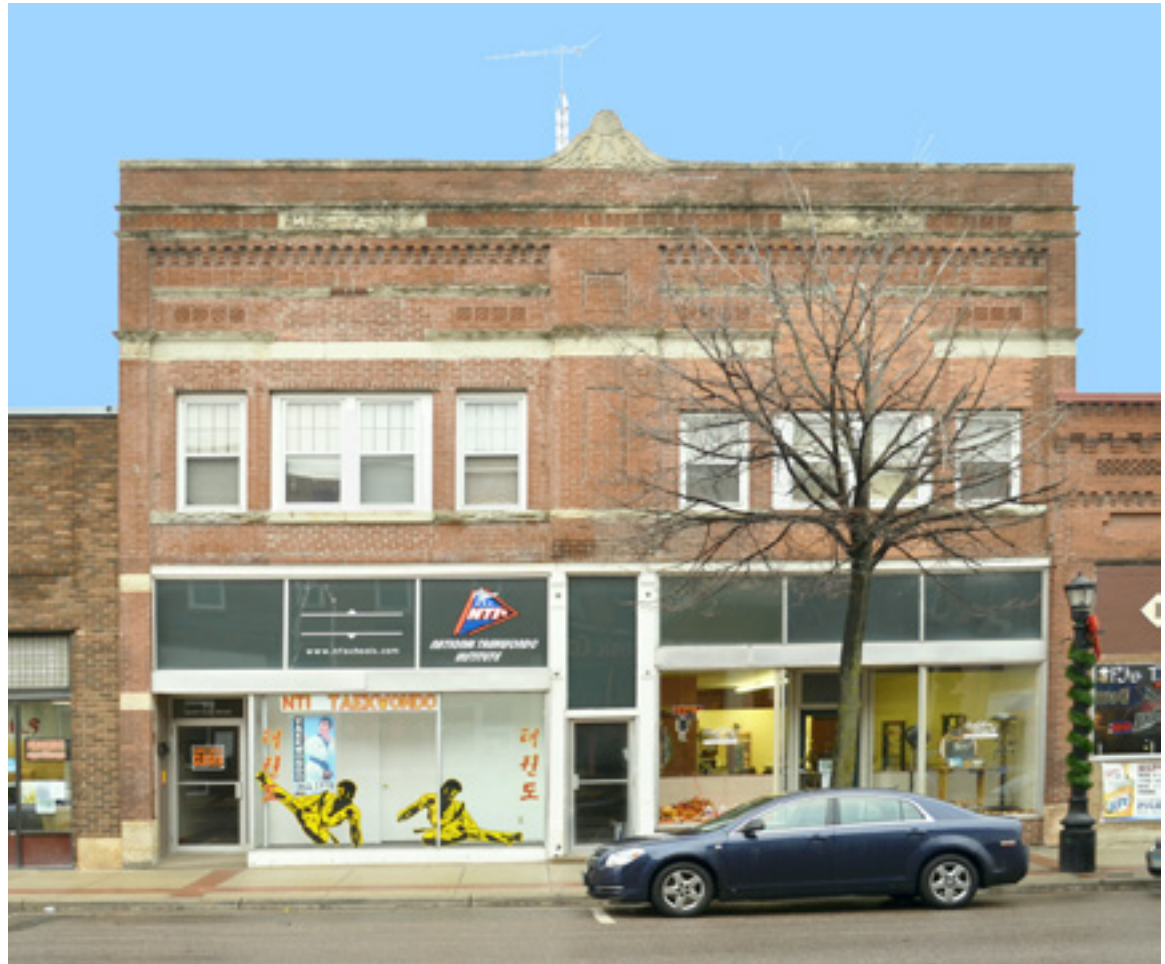
Lost features include: tall, projecting Oriel windows flanked by shorter windows in each of the two bays of the upper-story; and the original storefronts.

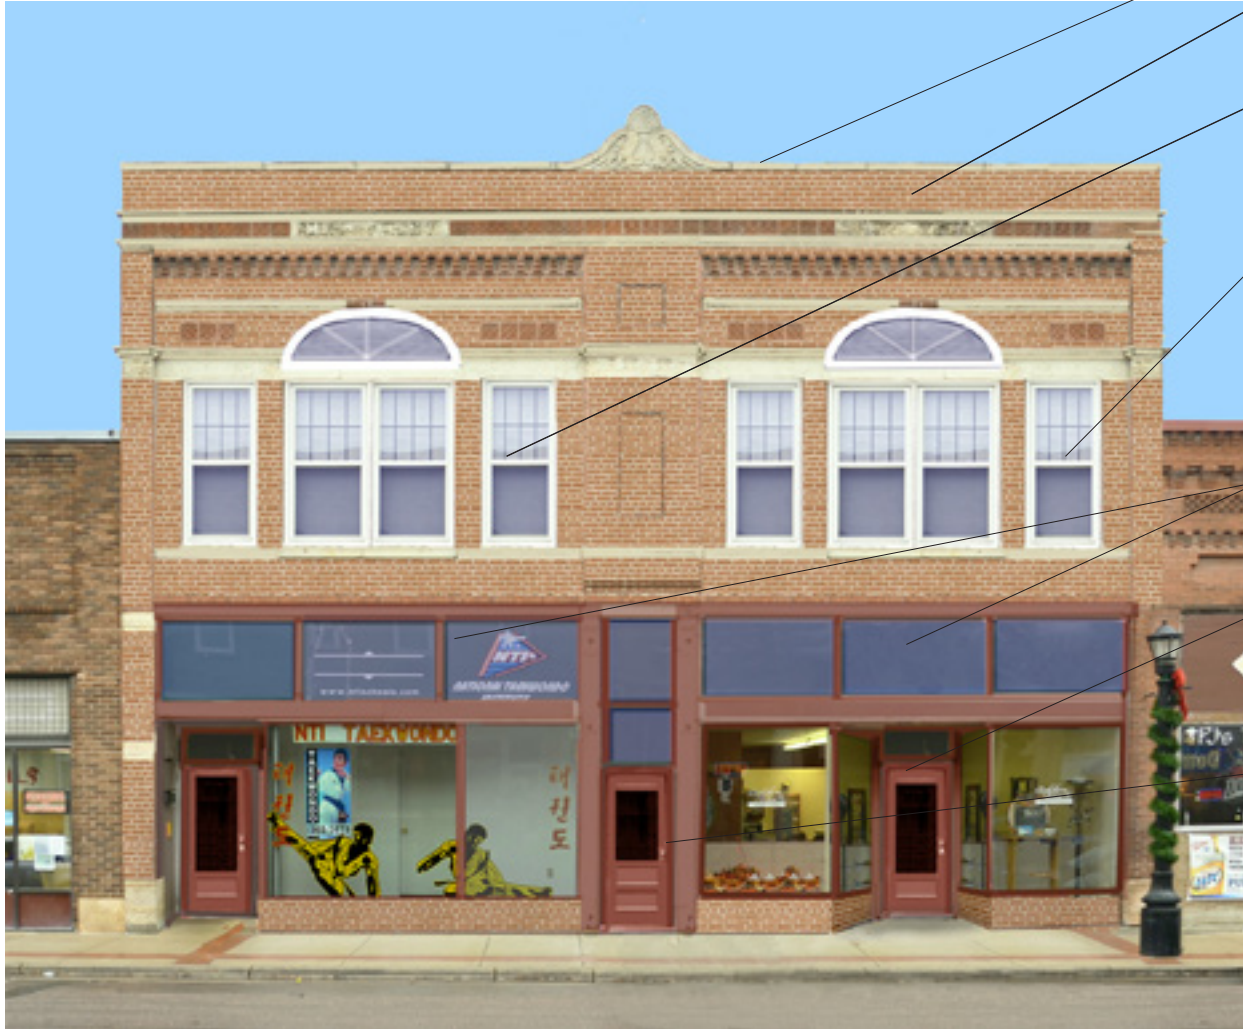
- Inspect roofing, coping and flashing.
- Repoint and repair brick and stone banding.
- Replace short windows at 112 and replace with windows sized to the original window opening as designed in the 1890s.
- Remove the shorter windows on the upper-story at 100 and enlarge the window open to install windows of the same configuration as those at 112. New double-hung windows should be double-insulated.
- The transom windows above the two storefronts should be the same in design, materials, and dimensions.
- Construct a storefronts with recessed commercial entries, wood and glass doors, bulkhead below large display windows.
- Replace the center 2nd-floor entry door with a wood and glass unit and transom that compliments the new storefronts. Design of the secondary door should suggest different use than the commercial door sets on either side.

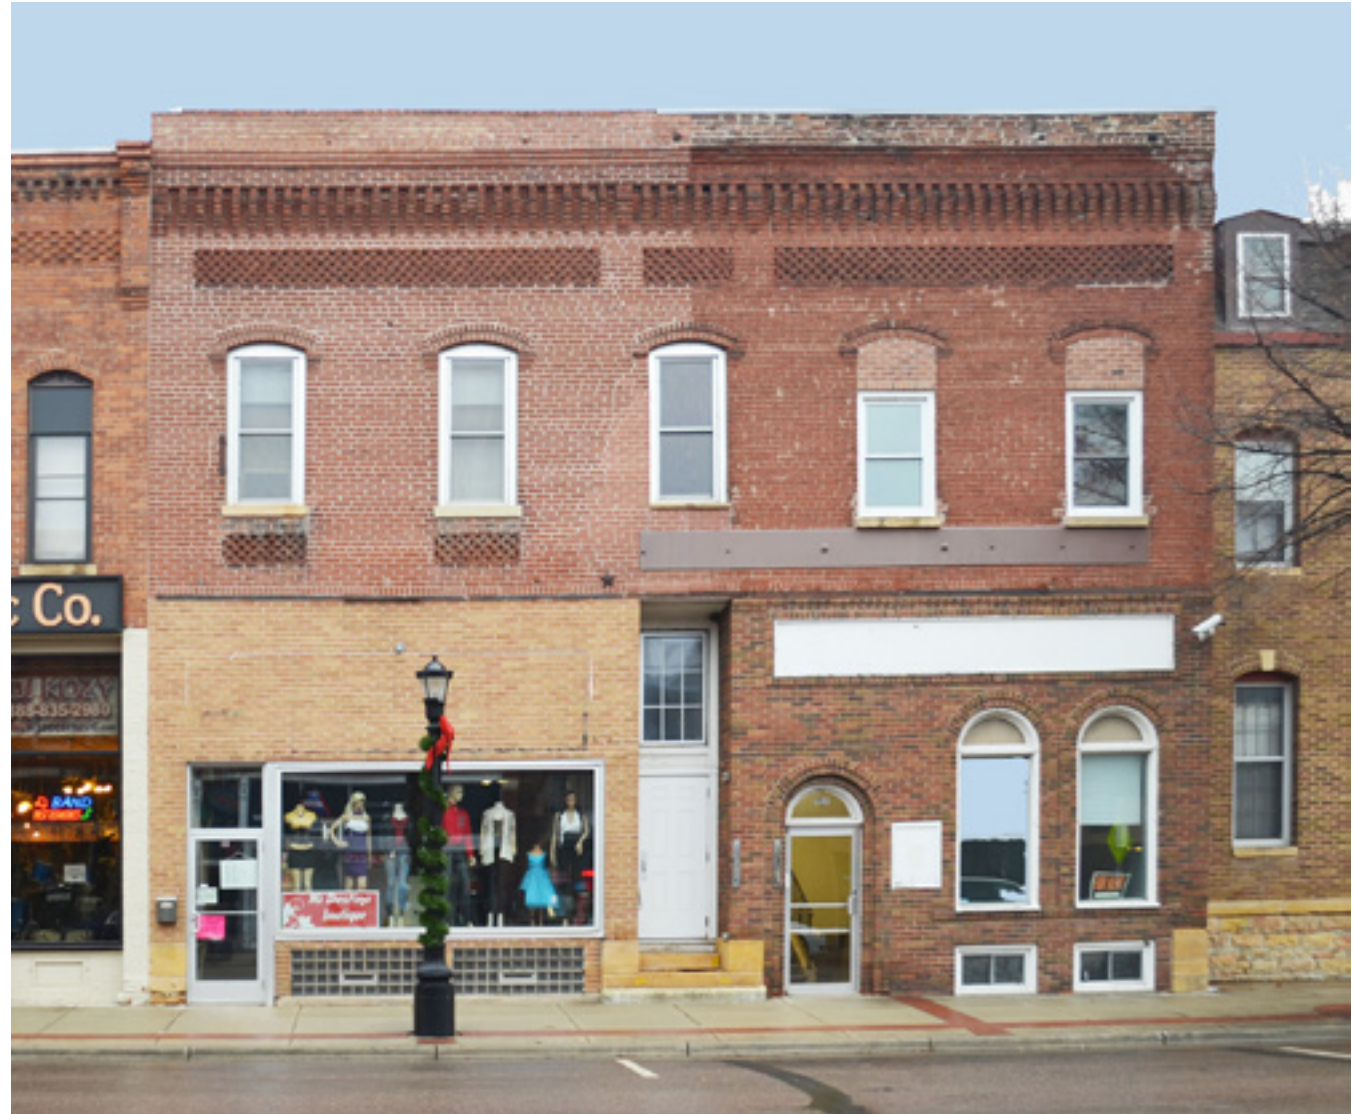
Over time this building has had separate owners resulting in various modifications and differing levels of maintenance. The structure displays significant structural problems that have required brick wall bracing as seen on the southern half of the upper story. The most dramatic changes have taken place at the storefront level with both storefronts being dramatically modified from their original appearance.

- Inspect roofing, coping and flashing.
- Install decorative cornice to replace lost cornice.
- Repoint and repair brick and standardize brick and mortar color and weight as much as possible.

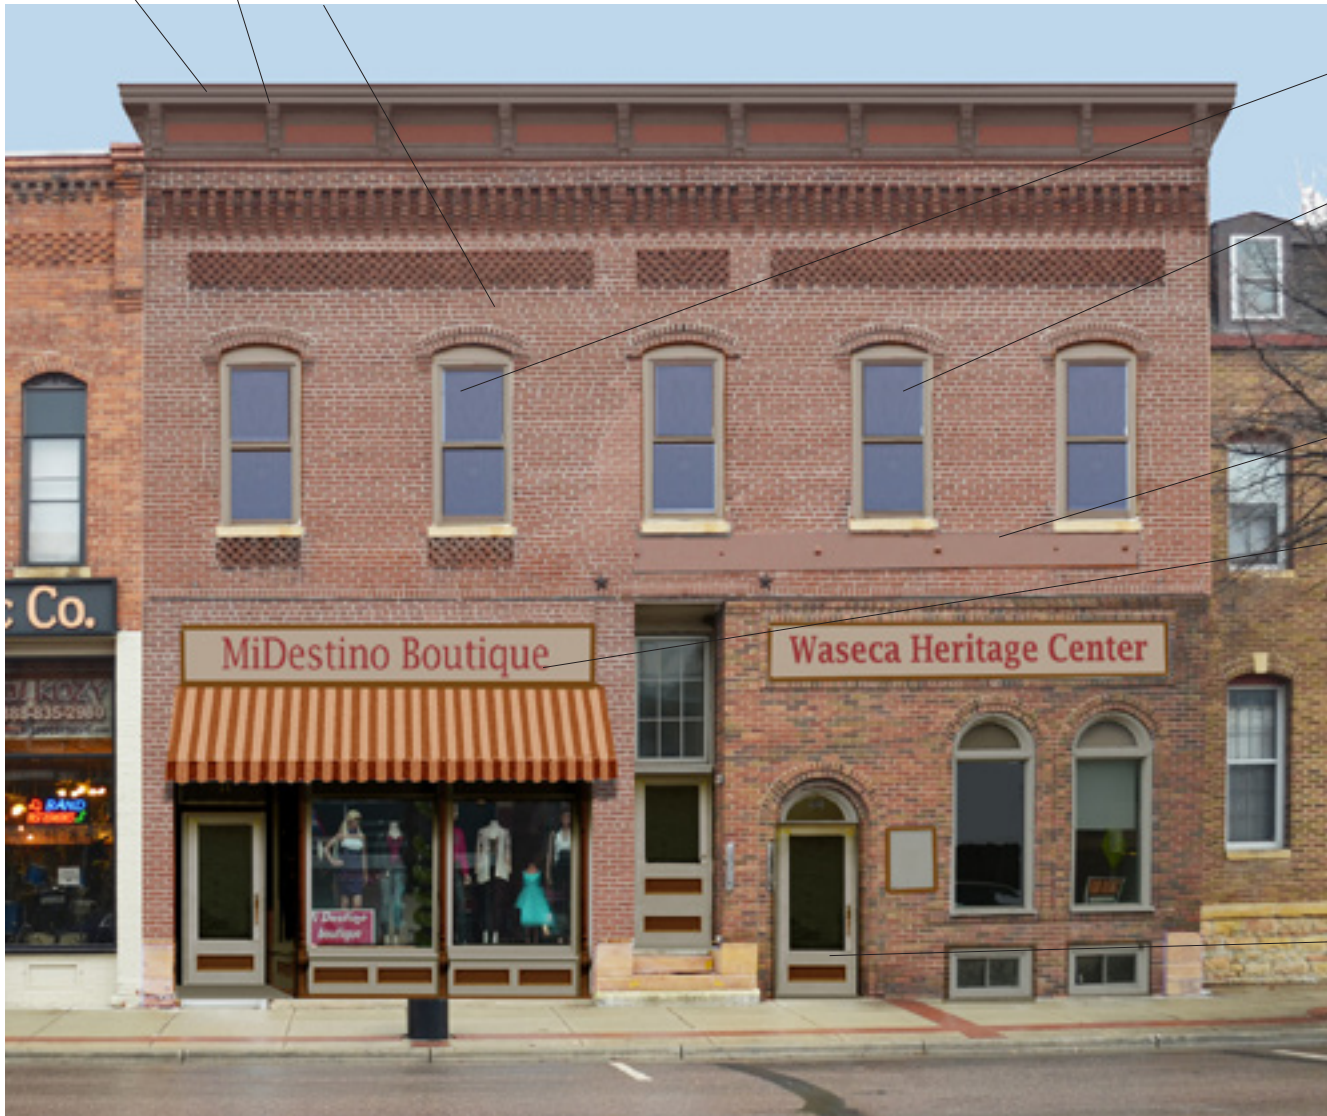
- Repair or replace the existing 1-over-1 upper-story windows at 113 State Street North.
- Remove the two short windows at 115 and enlarge the window openings to install windows of the same configuration as those at 113. New 1-over-1 double-hung windows should be double-insulated.
- Paint the iron brace plate on 115 to blend with the brick.
- The cream-colored brick and modern storefront should be removed from 113 and a flush signboard, canvas awning, and new storefront installed to fit the age and architecture of the building.
- All wood elements on the building should be color coordinated to create unity of appearance.
- Replace the center 2nd-floor entry with wood and glass door and transom. Design of the secondary door should suggest a different use than commercial door sets on either side.

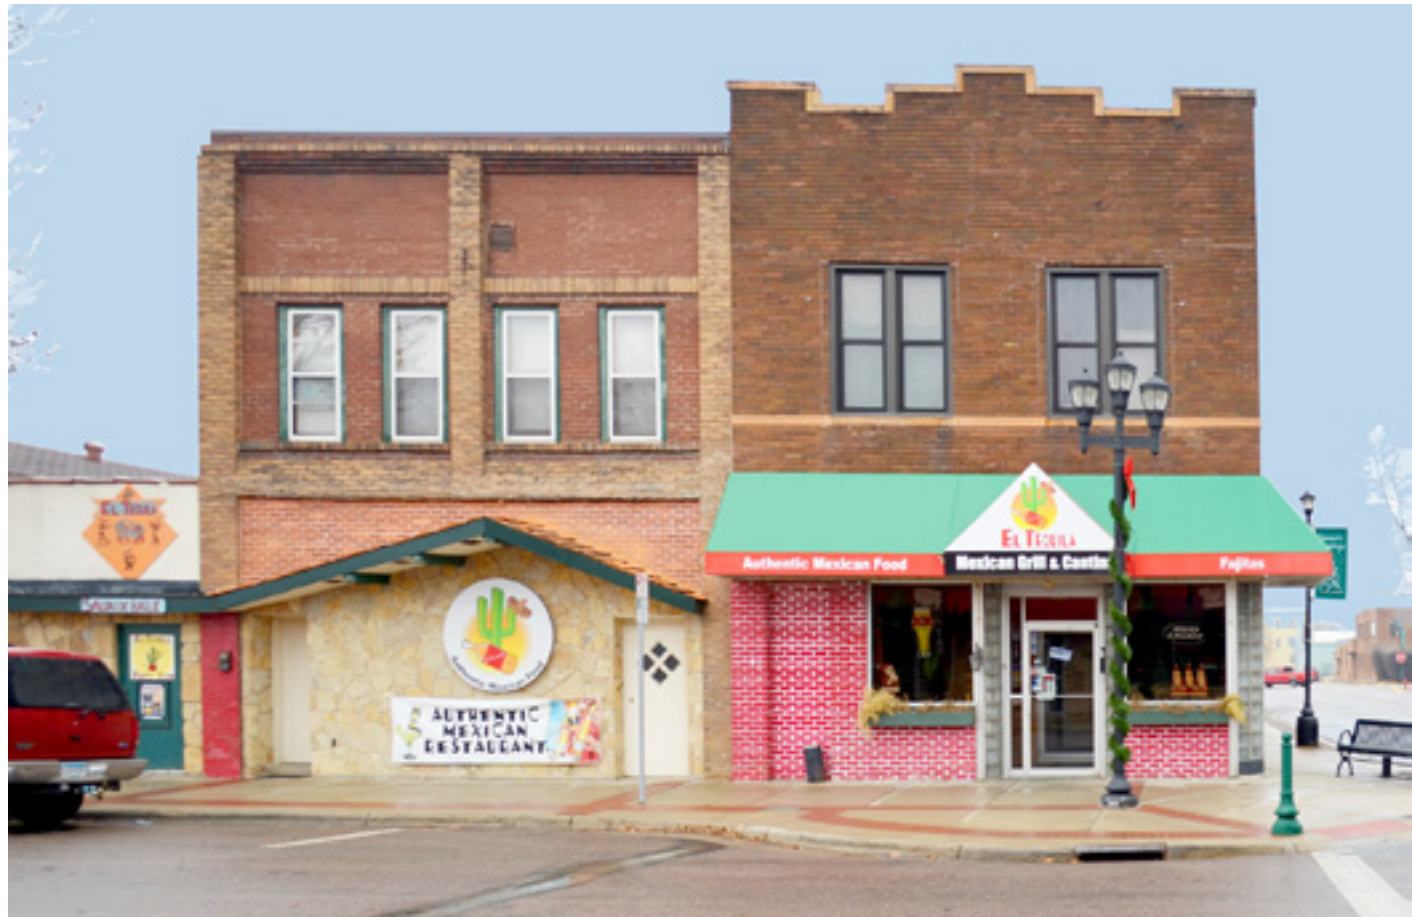
These early-20th century, vernacular, brick-faced commercial buildings retain most of their upper-story integrity, however their storefronts have been modified and reflect multiple uses and ownership through the last century. The storefront at 200 State Street South even displays the remnants (structural glass block panels) from the Art Deco period.

- Inspect roofing, coping and flashing.
- Clean the cornice.
- Clean brick on both buildings as necessary.
- Determine the condition of the windows in the upper story of 204 State Street South. If they are undersized or need to be replaced coordinate them with the windows in the adjacent building at 200. New windows should be double-insulated.
- The infill modern storefront on both buildings should be considered for complete removal and replacement with more appropriate materials and design.
- With the two addresses sharing on business care should be given in the storefront treatments to clearly define two unique buildings, but coordinate color palette in signage and awning fabric.

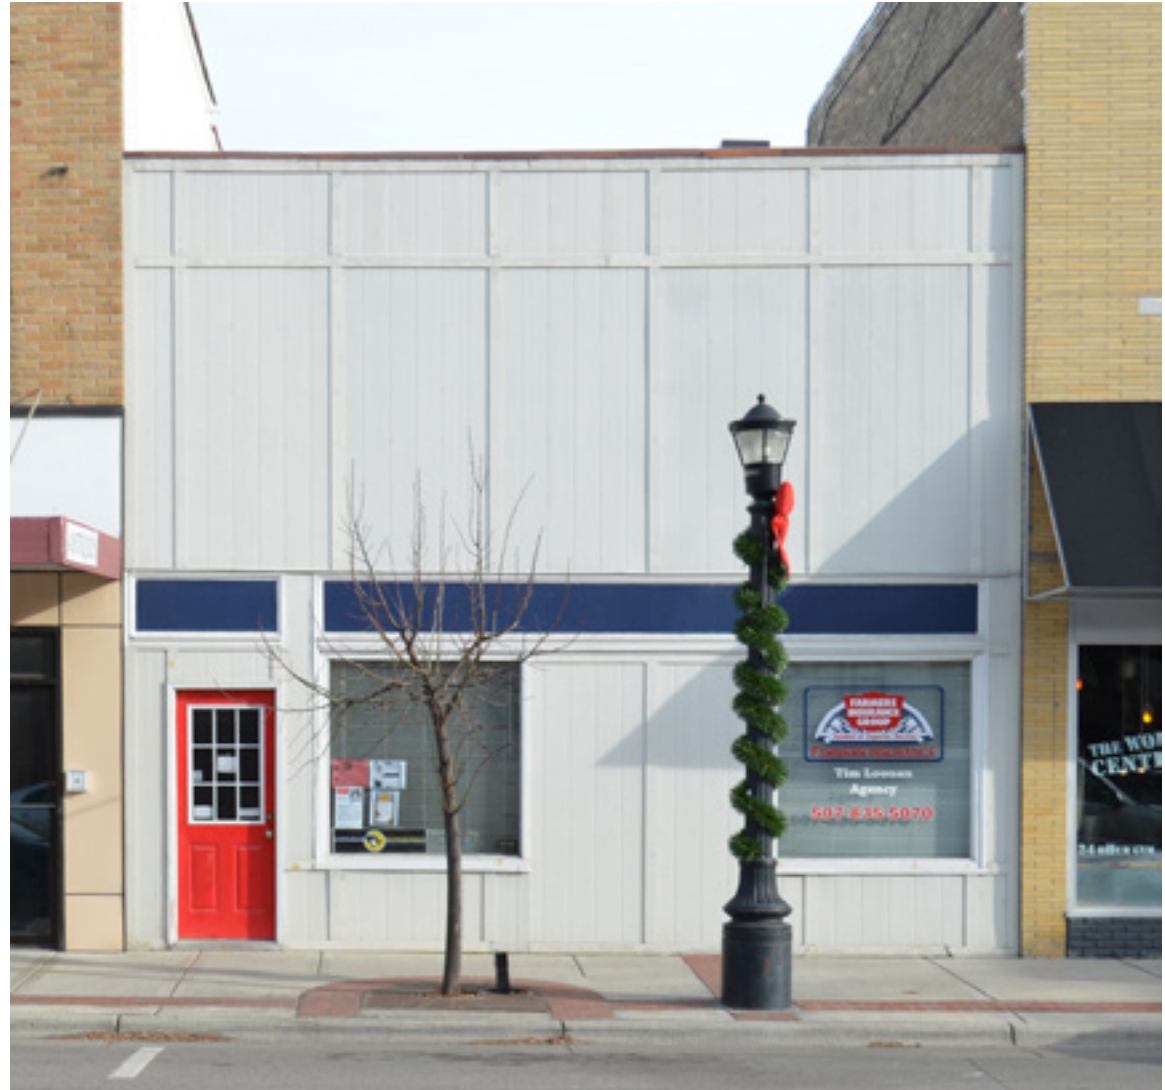
What may remain of the 19th-century, vernacular, commercial block has been covered with wood paneling. What can be determined from the "ghosting" profile on the adjacent building to the south, is that the original structure was two stories tall with a one-story extension off the back.

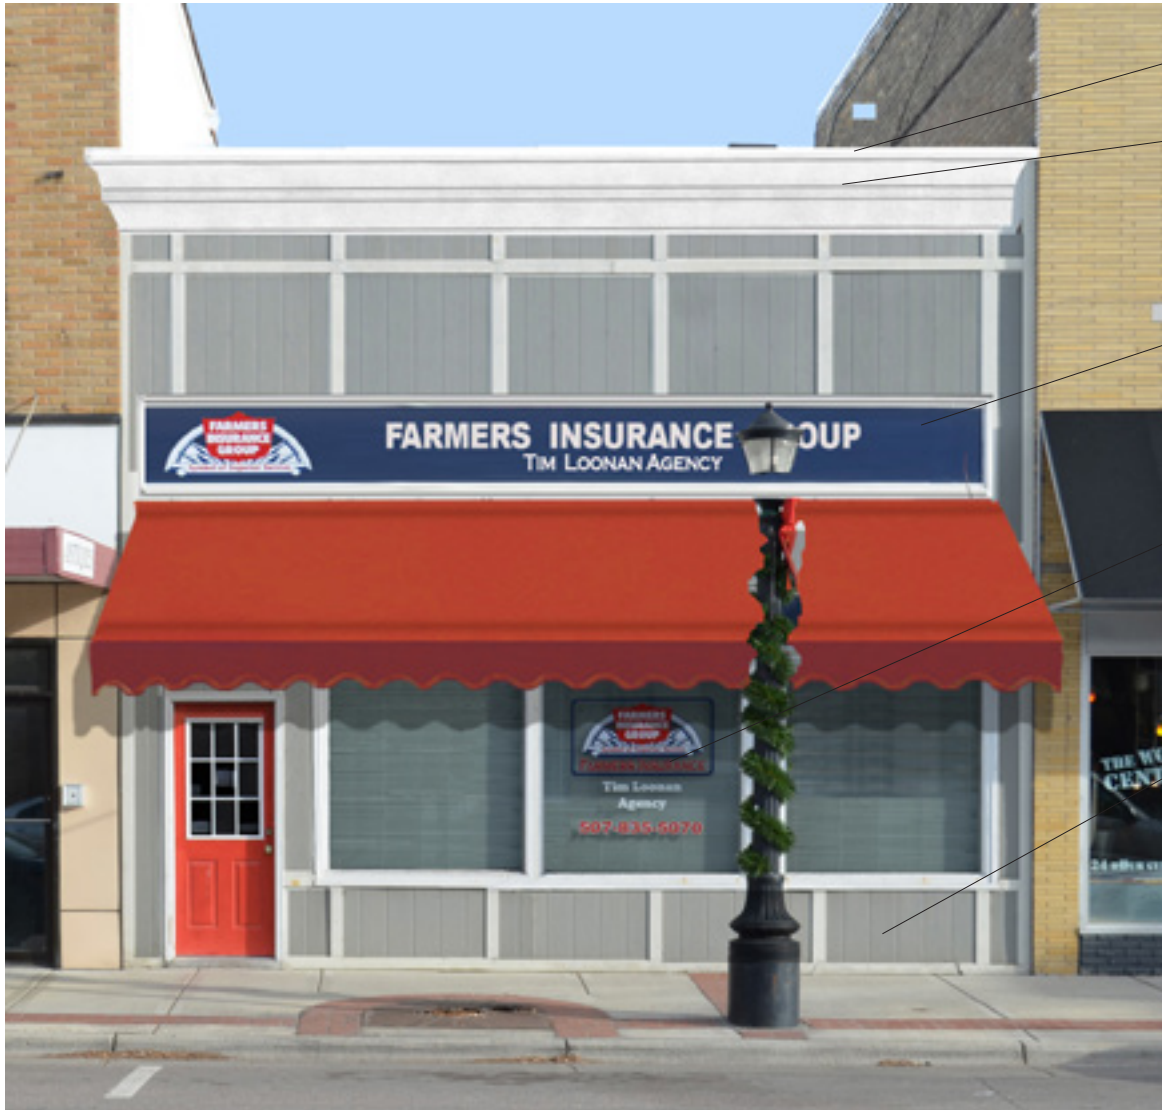
- Inspect roofing, coping and flashing.
- Consider the addition of a crown molding to give the building some compatibility with its older neighbors.
- Install signboard that spans the width of the building. It should be flush and be located above the retractable canvas awning.
- A center display window should be added between the existing windows. The expanse of glass will enhance the commercial continuity of the streetscape.
- A simple, color combination paint job can add visual interest to this relatively simple box.

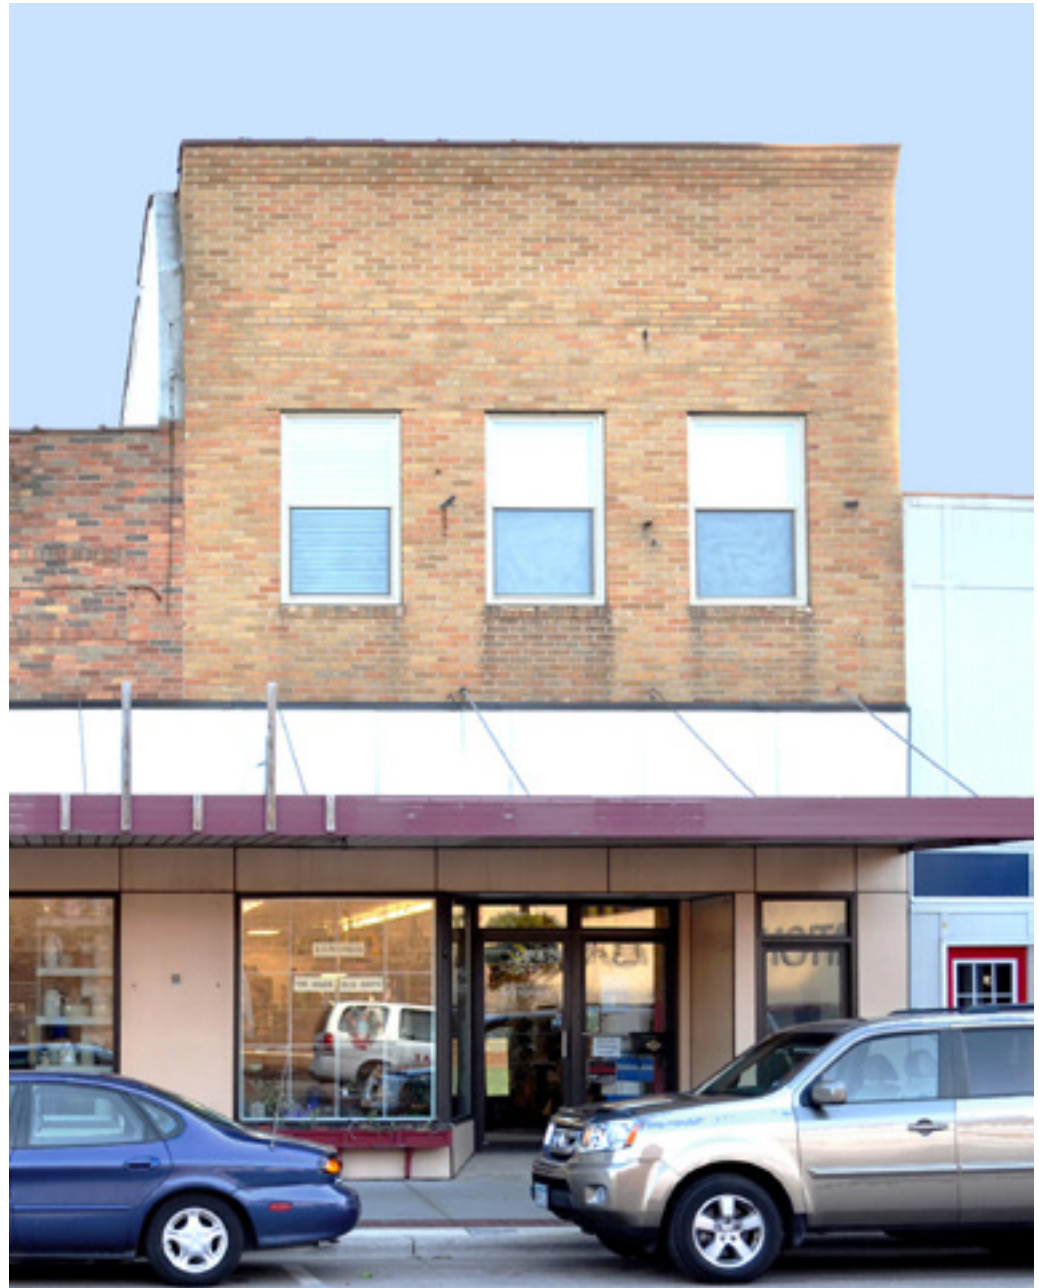
Like other properties along State Street this building has gone through change in the 20th century. The upper-story design and brick type appear to date to the first half of the 1900s while the original storefront has been sheathed in mid-century glazed panels and a projecting metal canopy.

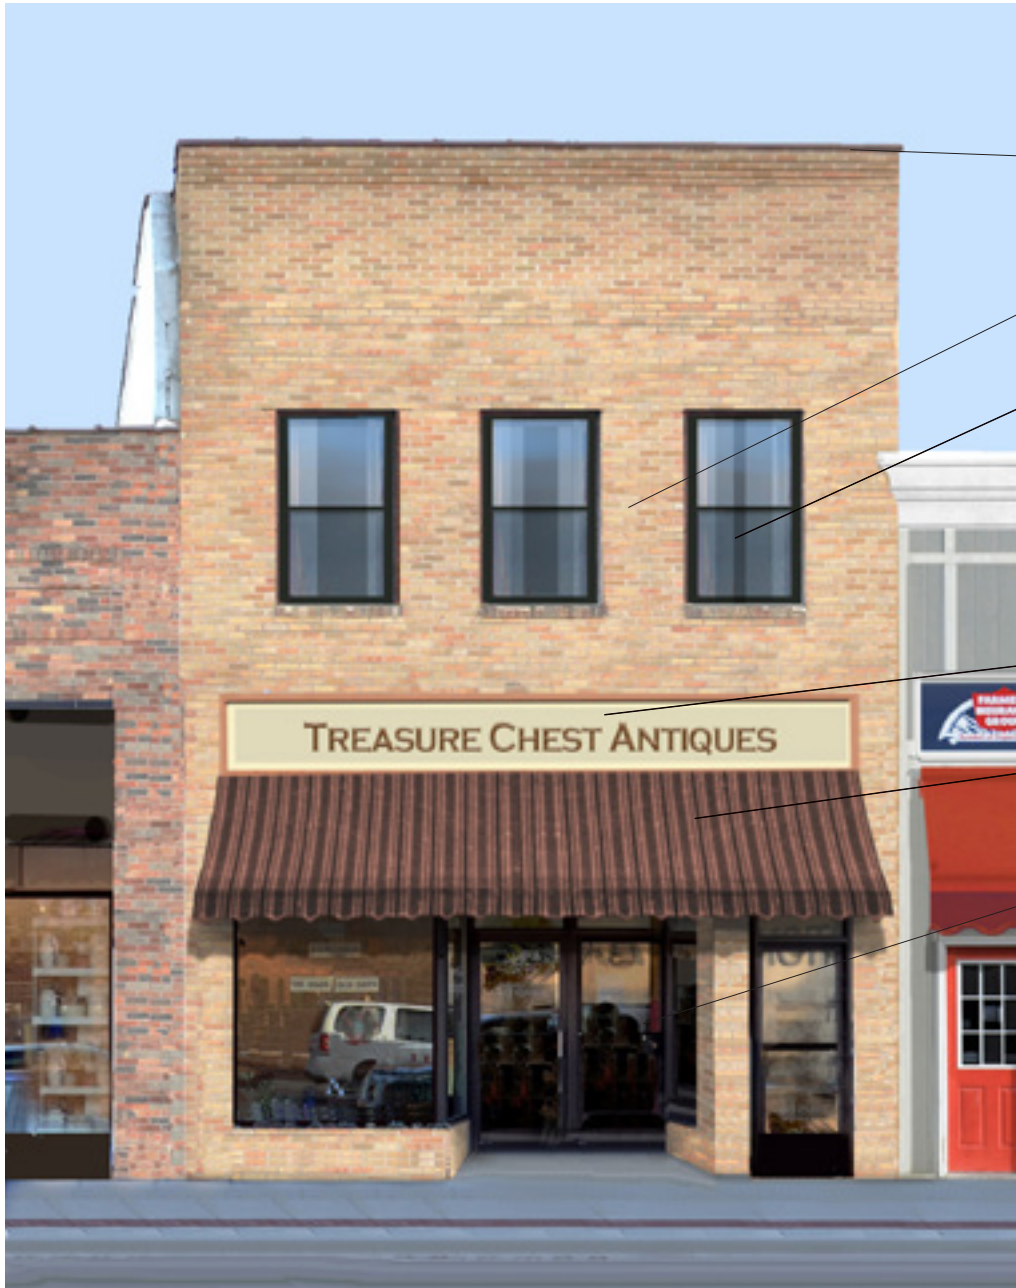
- Inspect roofing, coping and flashing.
- Remove from the facade any obsolete hardware or wiring and repair the brick as necessary.
- Remove the second story plywood infill and install windows to reflect the original fenestration in dimensions and profile. New windows should be double-insulated.
- Remove the glazed panels from the transom and the window surrounds, and remove the projecting metal canopy.
- Place commercial signage on a flush signboard of the transoms.
- Hang canvas, retractable awning above storefront.
- This rendering suggests retaining the existing anodized aluminum display and door set since it conforms to the standard historic storefront design with recessed entry flanked by tall display windows.

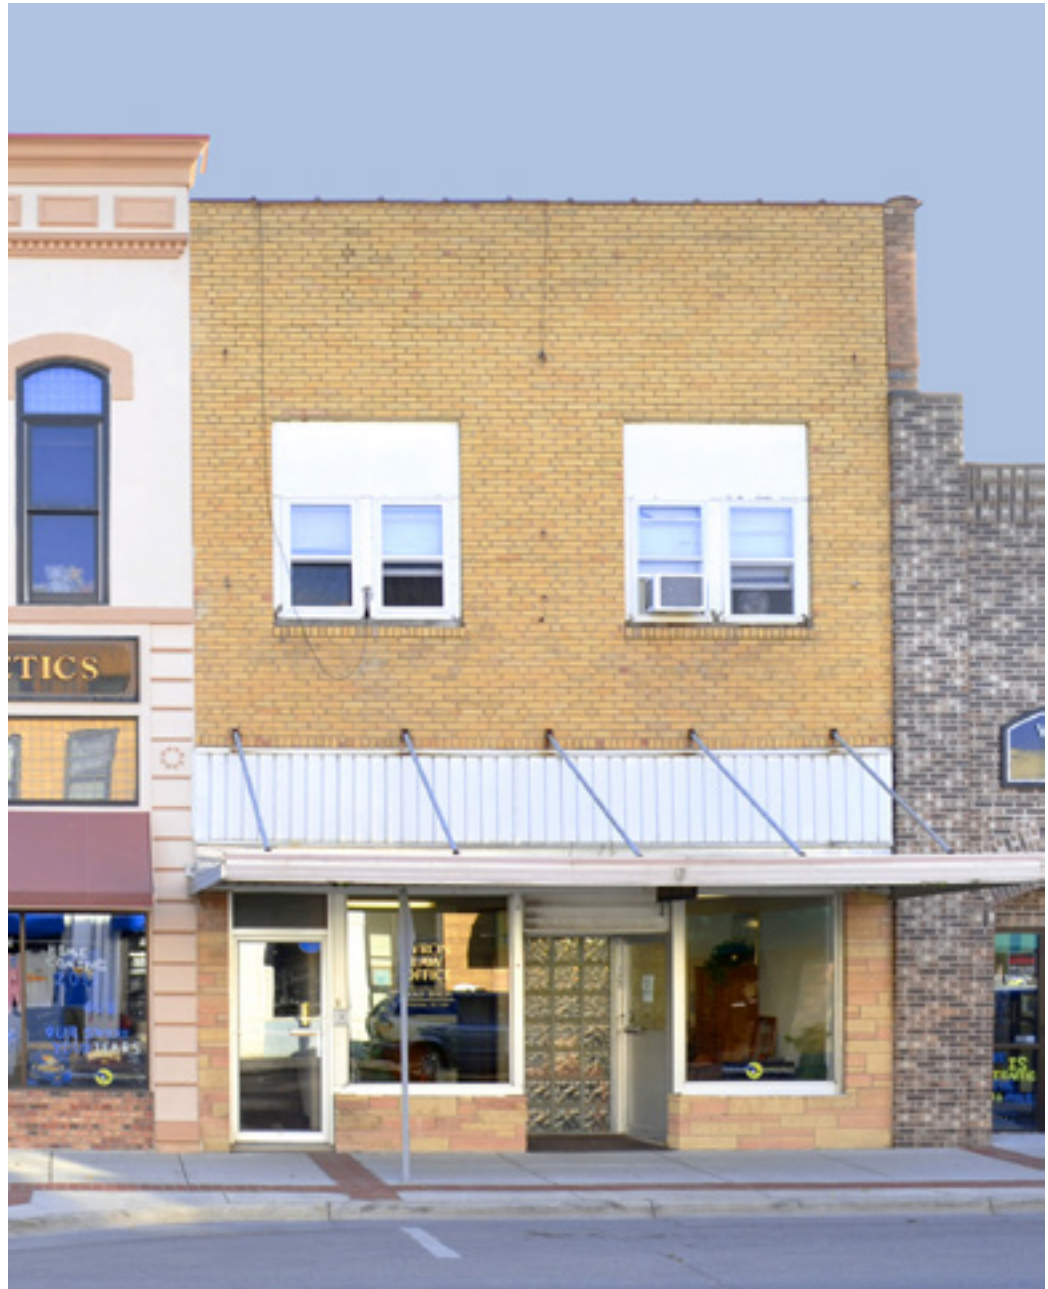
This early-20th century, vernacular commercial building is faced in cream-colored brick. While the storefront has maintained its original bay configuration, the transom has been covered with a ribbed panel and a metal canopy is suspended over the entries. The upper story displays two sets of down-sized windows.
