City of Waseca Downtown Preservation Design Guidelines

Prepared for
The City of Waseca and the Waseca Heritage Preservation Commission

Prepared by
Thomas R Zahn & Associates LLC
Spring 2014

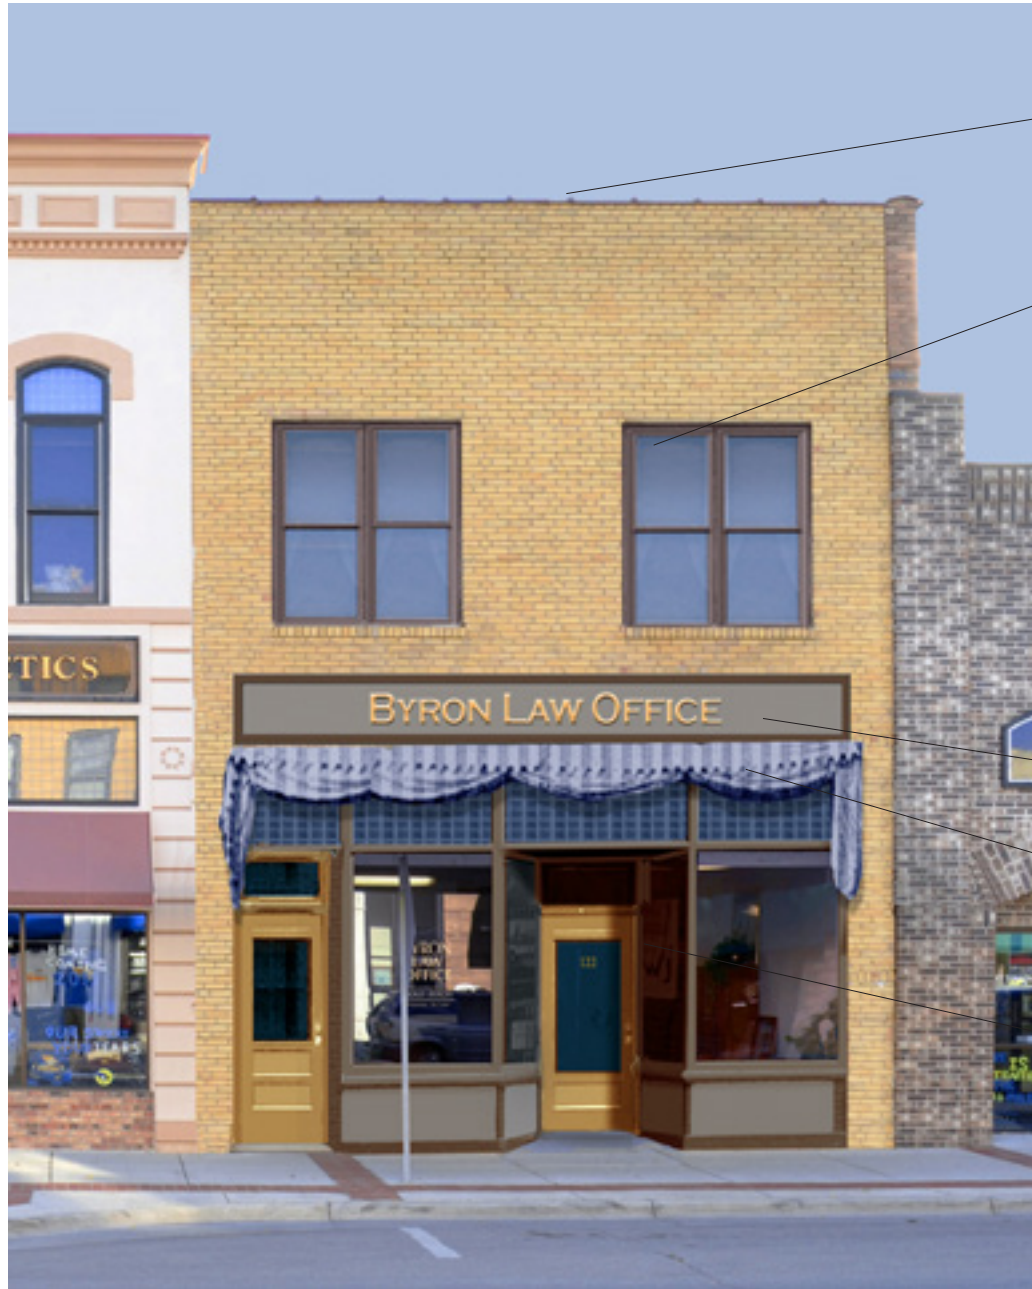
This early-20th century, vernacular commercial building is faced in cream-colored brick. While the storefront has maintained its original bay configuration, the transom has been covered with a ribbed panel and a metal canopy is suspended over the entries. The upper story displays two sets of down-sized windows.

- Inspect roofing, coping and flashing.
- Remove from the facade any obsolete hardware or wiring and repair the brick as necessary.
- Remove the second story plywood infill and install windows to reflect the original fenestration in dimensions and profile. New windows should be double-insulated.

- Hang canvas, retractable awning above transom. If the transom has retained its glass make any necessary repairs to the original glass. If the glass is not longer there or beyond repair install new transom windows.

- Replace the modern aluminum display and door sets with wood and glass doors and display windows. The design of the apartment door to the left and the shop entry door should suggest different uses.

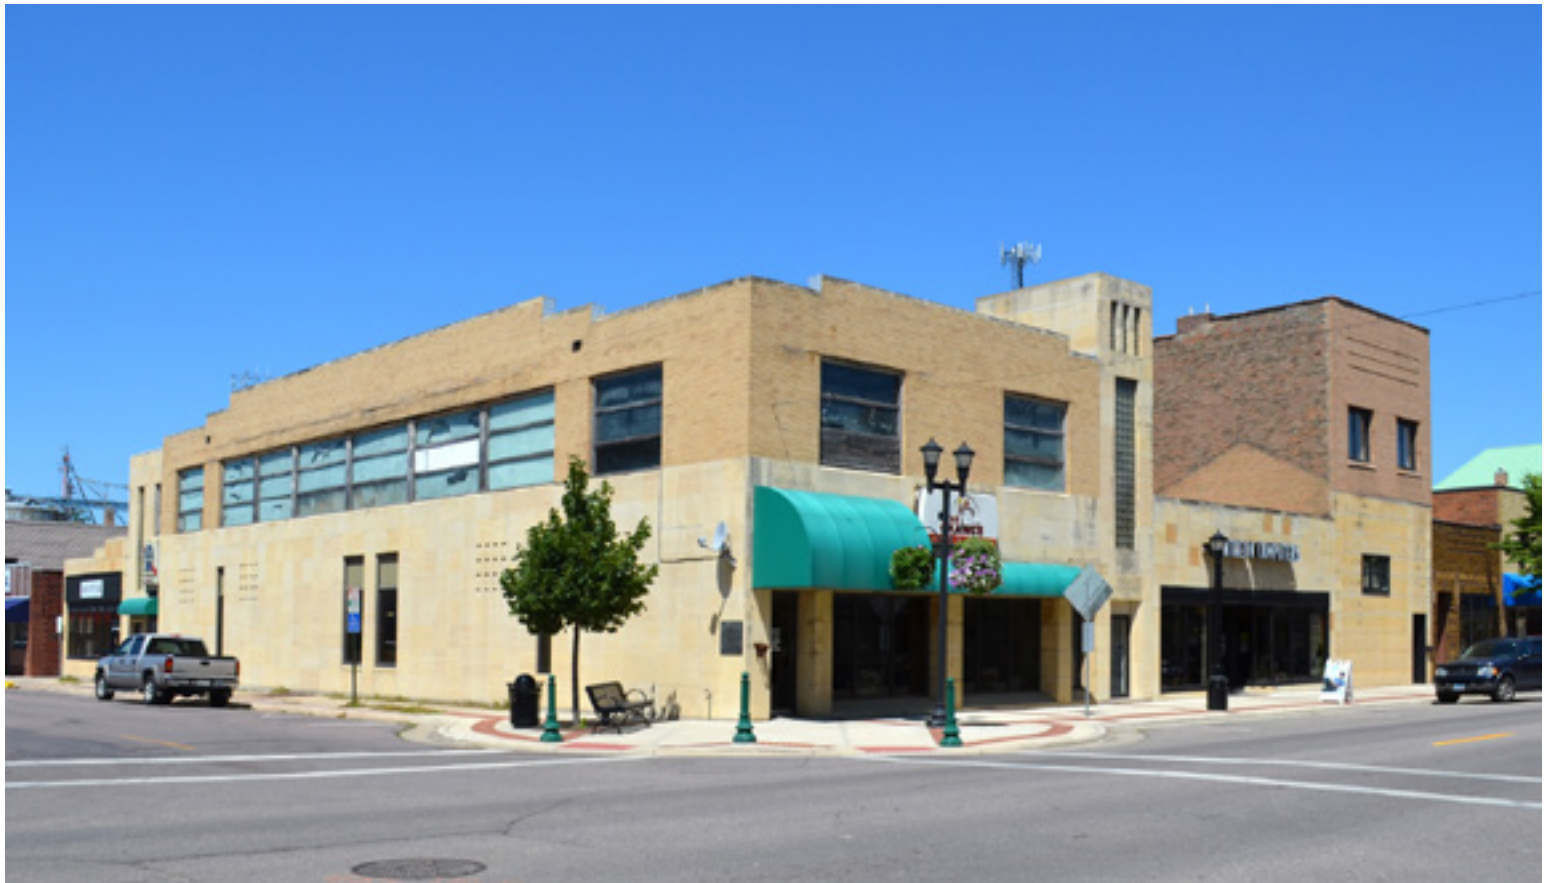
Built to house the State Farmer's Insurance Company, this space was occupied by a Ben Franklin store and the Waseca Mutual Insurance Company in the 1950s.

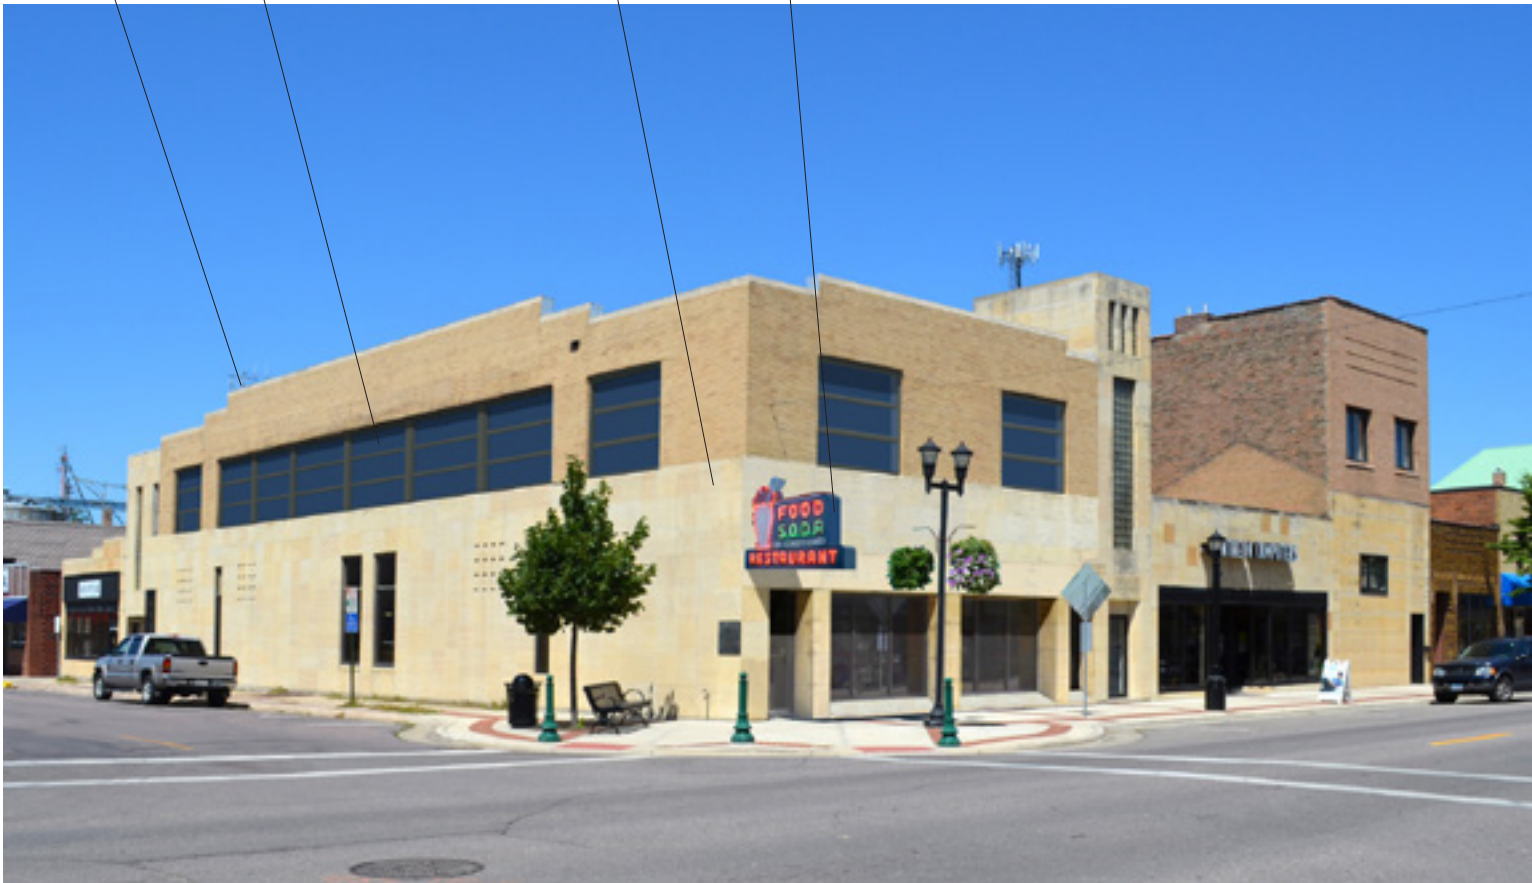
- Inspect roofing, coping and flashing, and clean brick as necessary.
- Install insulated glass in original industrial frames
- Remove inappropriate "waterfall" rigid awning and backlit plastic signage for the smooth exterior limestone.
- Clean and repair stone as necessary.
- Place new signage on windows or Art Deco designed flush or shallow projecting sign.

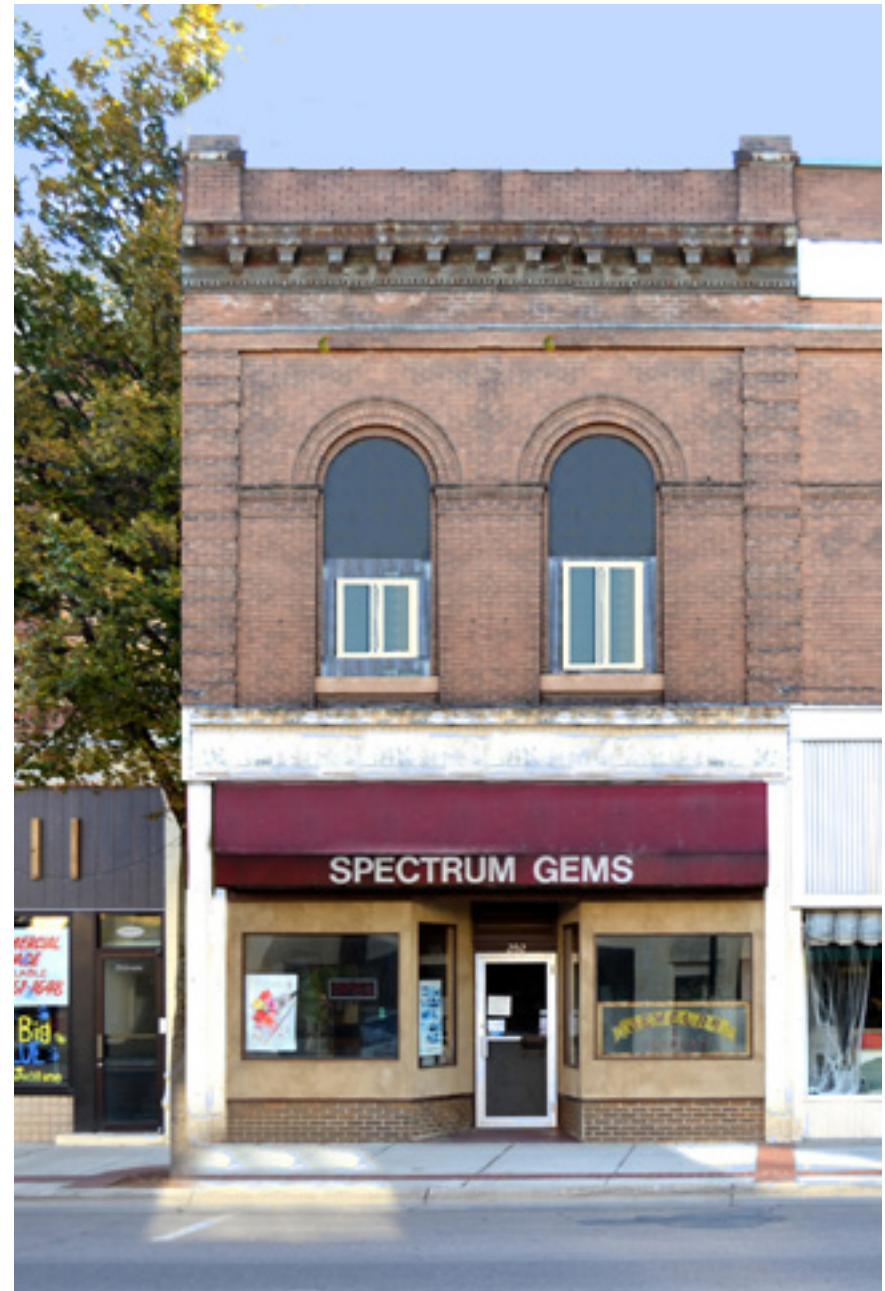
Built in 1898 as a general store, This brick-faced building displays similar architectural features to its adjacent block at 200 State Street. This handsome building displays Romanesque Revival features in its rounded-arch window openings, but has lost its original storefront.

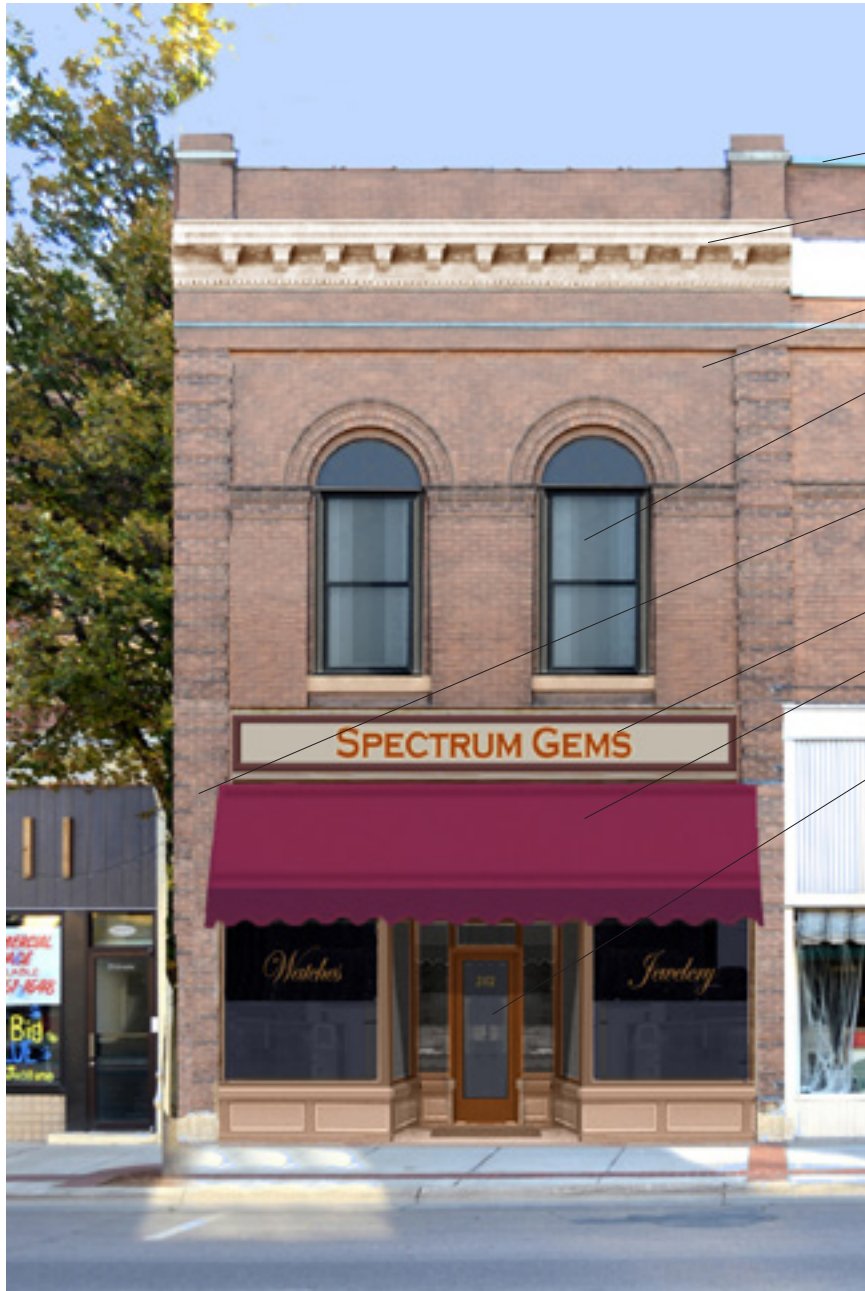
- Inspect roofing, coping and flashing.
- Clean, repair and repaint if necessary the original copper decorative cornice.
- Clean, repair and repoint the brick as necessary.
- Remove the arched window infills and install new 1-over-1 double-hung windows custom fit to the openings. The new windows should be double-insulated.
- Uncover the brick piers that should extend down both sides of the storefront opening.
- Place the signage in the existing signboard frame.
- Hang a canvas, retractable awning over the display windows and store entrance.
- The down-sized display windows and raw aluminum entry door should be replaced with a reconstructed wood and glass storefront with large display windows, center doorway with transoms above and bulkheads below.

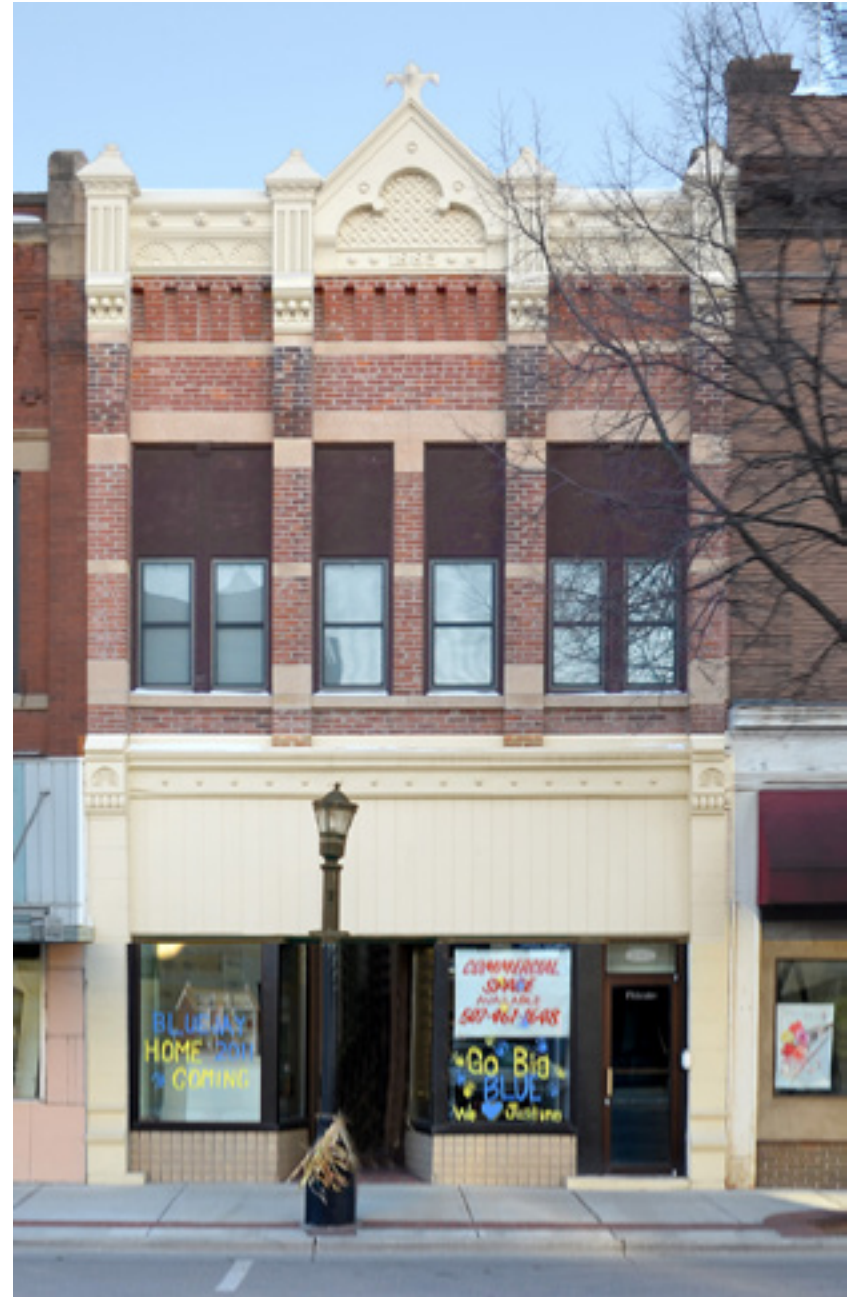
The major changes to the original design are down-sizing of the upper-story windows, the covering of the transom band, and the modernization of the storefront opening.

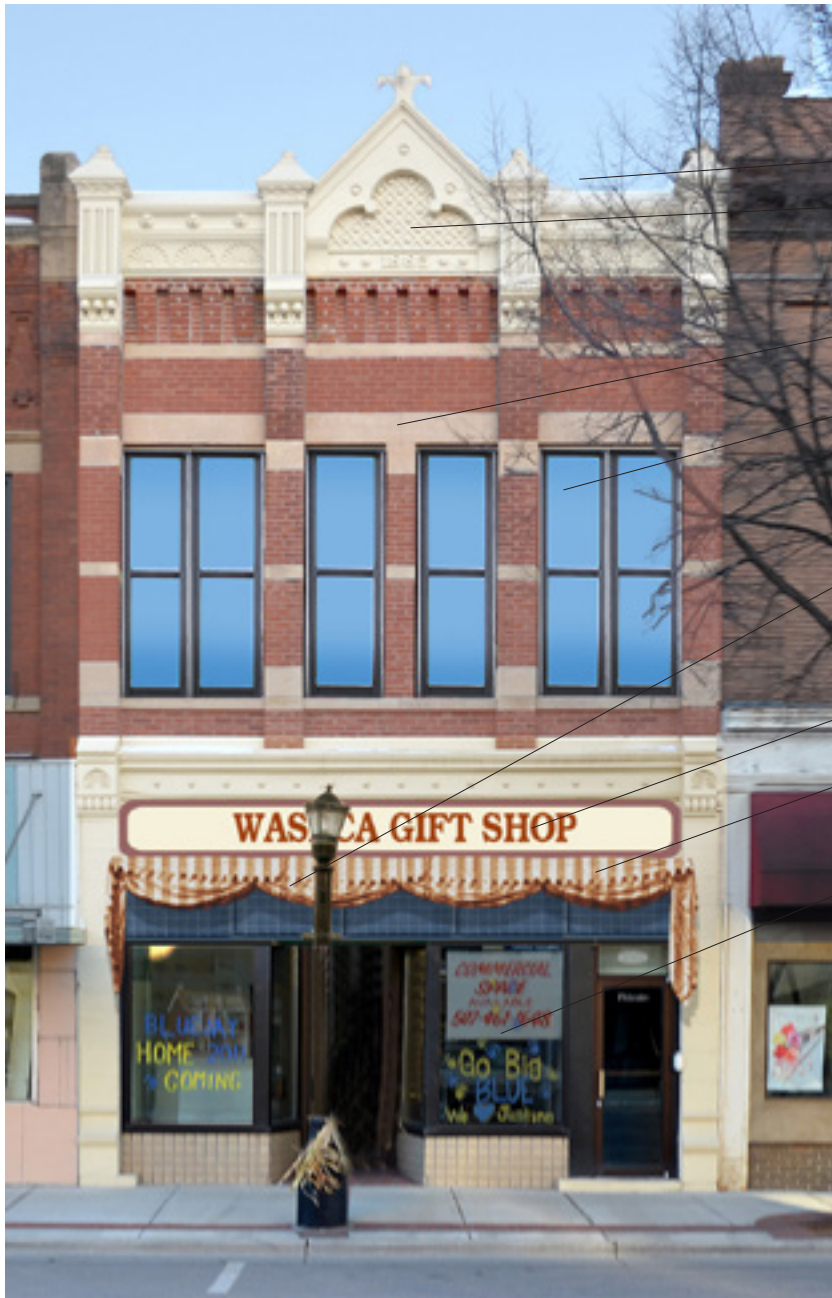
This late -19th century block is faced with red brick, stone, and decorative metal stone and wood. The construction date is found in raised letters in the elaborate building cornice and crown.

- Inspect roofing, coping and flashing.
- Paint if necessary the original decorative metal cornice. Consider a multi-chrome application that would accentuate the ornate textures of the elaborate crown.

- Clean, repair and repoint the brick and stone details as necessary.
- Remove the infill panels and down-sized windows in the upper-story and install new 1-over-1 double-hung windows custom fit to the openings. The new windows should be double-insulated.

- Remove the metal paneling over the transom opening. If the transom has retained its glass make any necessary repairs to the original glass. If the glass is not longer there or beyond repair install new transom windows.

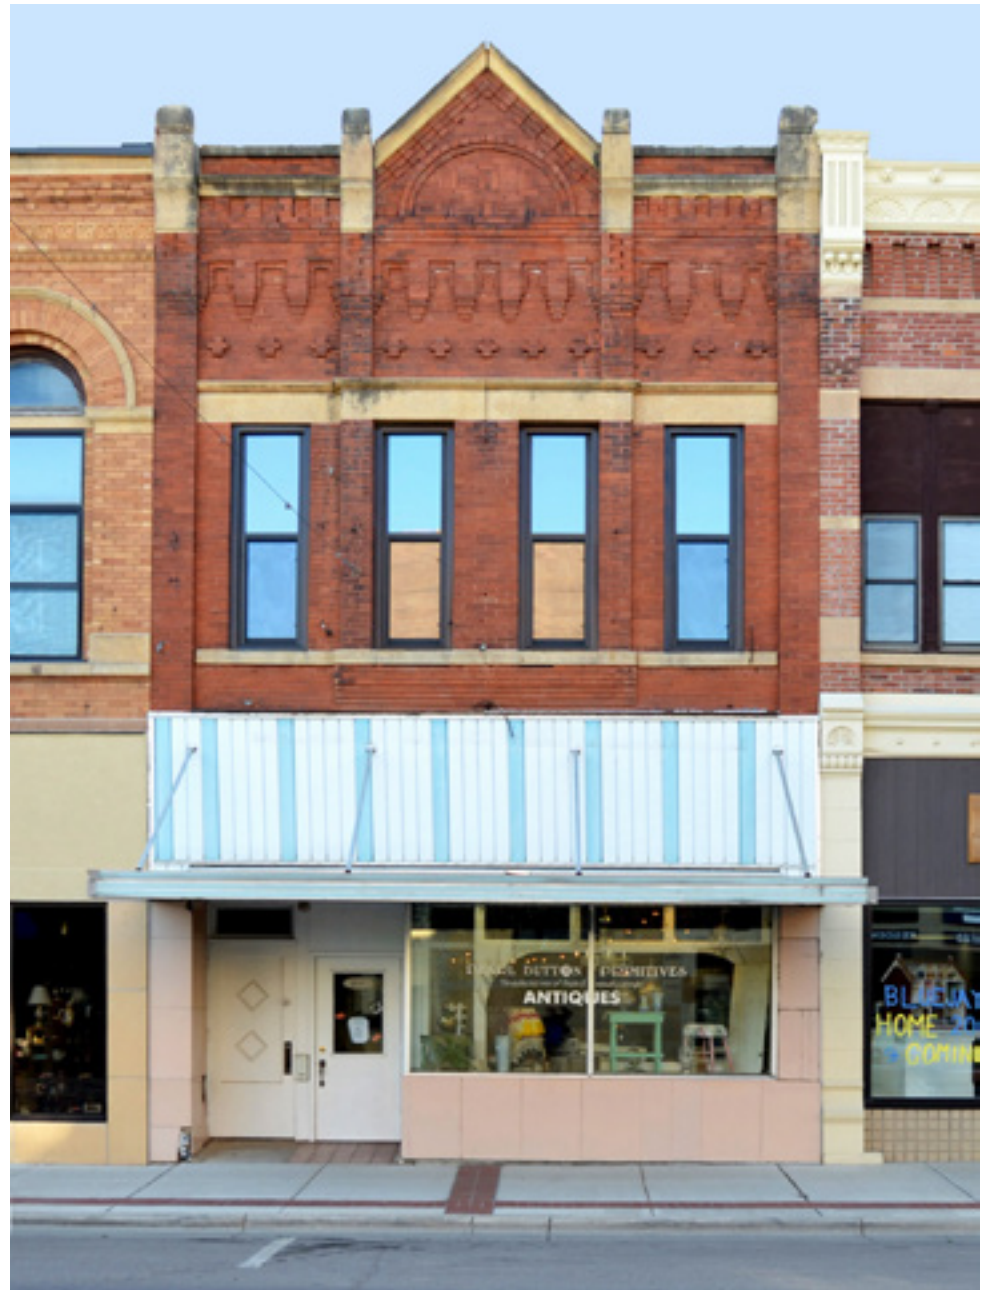
At the storefront: the transom has been covered with vertical-ribbed metal, a metal canopy was suspended from the transom, and a mid-century storefront replace the original entry and display windows.

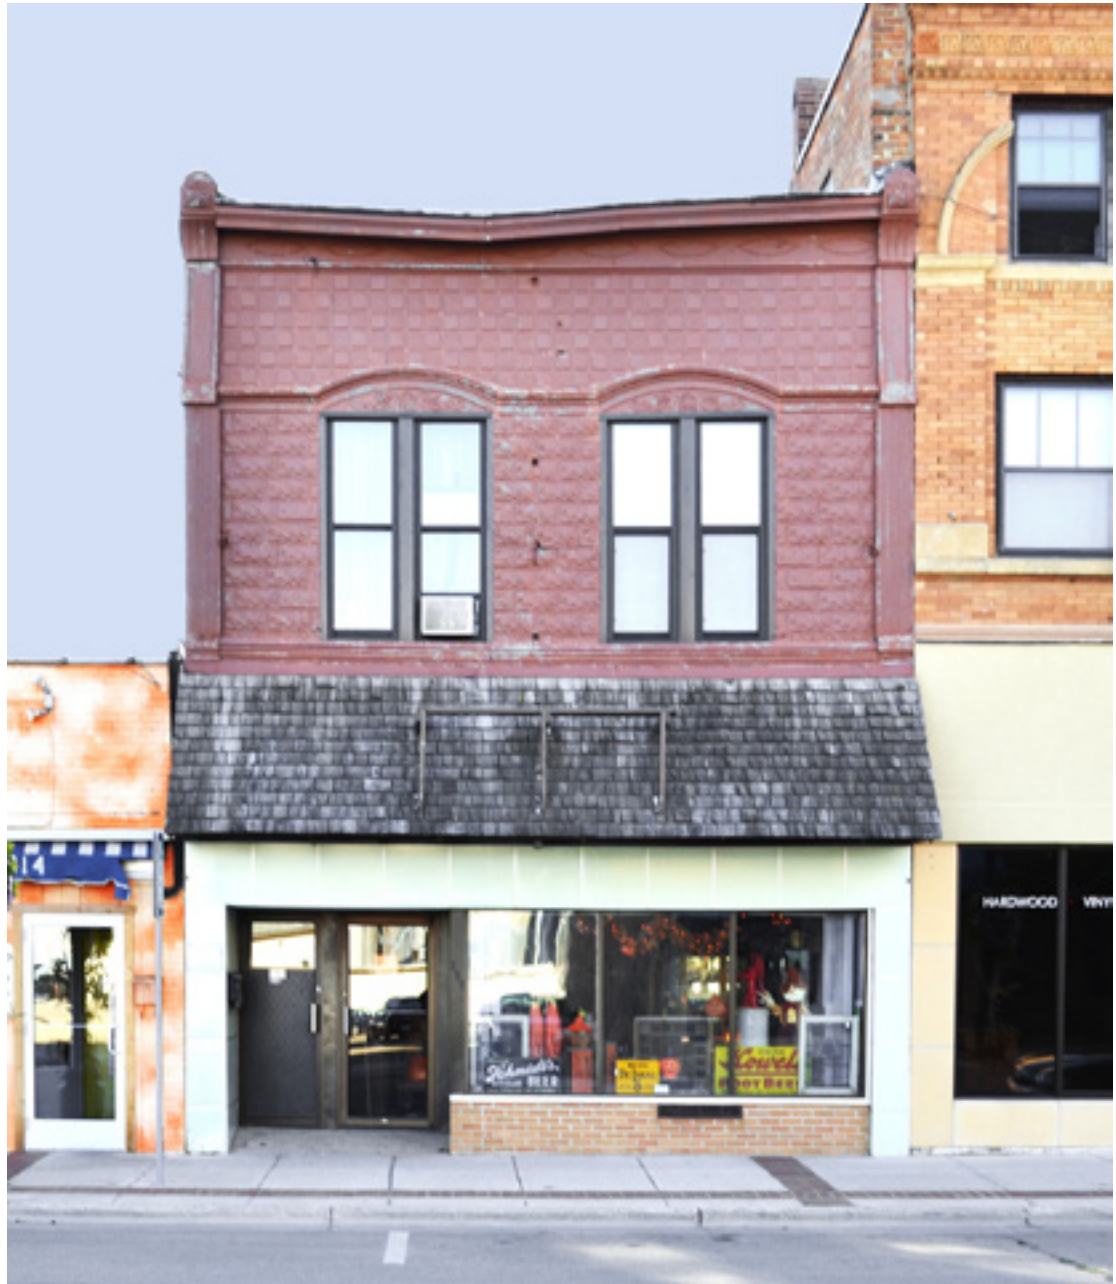
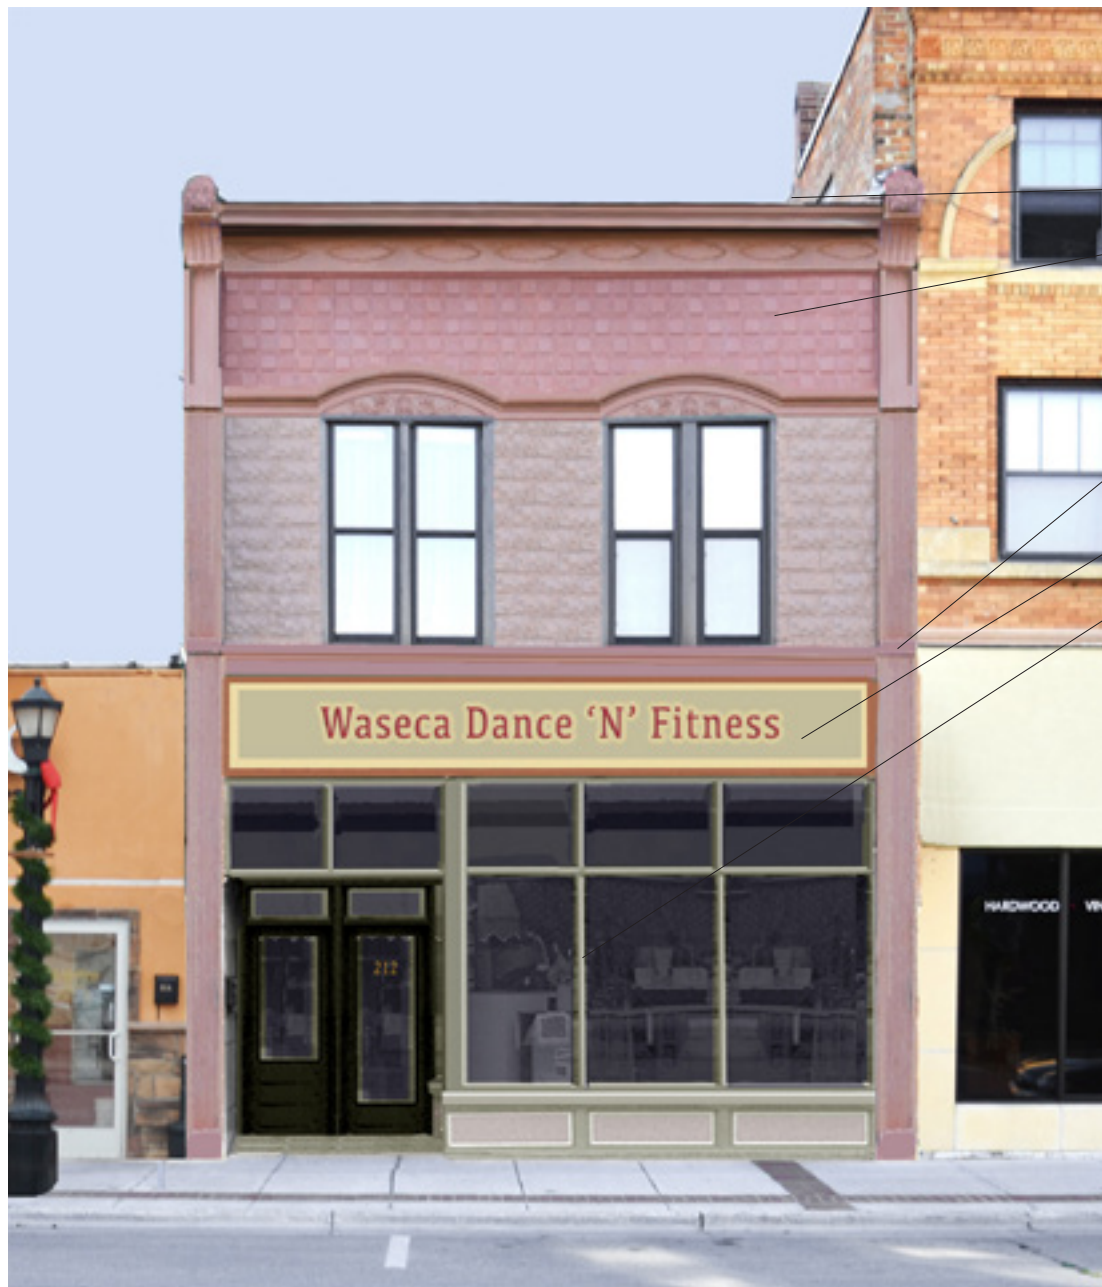
This late 19th century 2-story Italianate commercial block has an upper facade that is sheathed in decorative pressed metal sheets and banding.

The transom is covered with a shallow projecting pent panel covered in cedar shakes. The storefront was completely rebuilt mid-century in new brick, enameled panels, and aluminum framed windows and doors.

- Inspect roofing, coping, parapet and flashing.
- Repair, clean and repaint the decorative metal sheathing on the upper story.
- Remove the inappropriate shallow projecting pent panel covered in cedar shakes.
- With the paint application continue the side piers down to frame the storefront opening.
- Place the signage over the storefront transom.
- Remove the existing collection of storefront elements and reconstruct the storefront in wood and glass with large display windows, transoms above, bulkheads below, and adjacent doorways to the commercial and the upper level floors. The design of the shop door and the apartment doors should clearly suggest different uses.

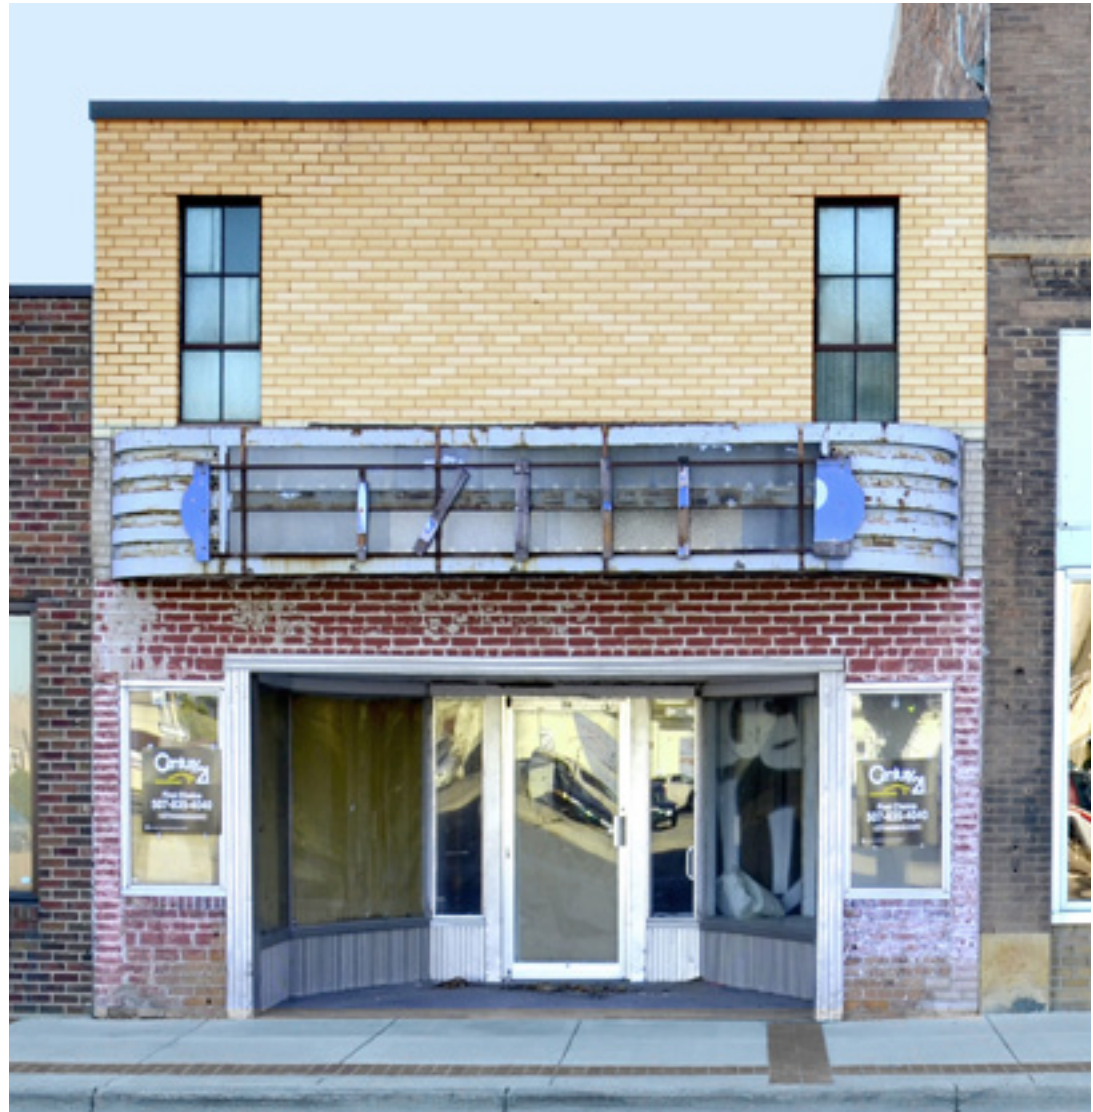
218 State Street North Jellum & Donovan Grocery/Park Theater (1897, circa 1930)

This site once housed a grocery store on the first floor and a photography shop on the upper level. When the building was converted into a movie house the building elevation was re-designed with art Deco features including the marquee and the recessed decorative aluminum-framed entry and windows.

- Inspect roofing, coping, and lashing on the roof.
- Repair, repoint and clean the brick as necessary.
- Clean and repair the crank-out windows on the upper level.
- Repair the marquee and use it to advertize the commercial reuse of the building.
- Sheath the surround and theatre entry in new black Vitrolite-like panels.
- If possible clean and maintain the extruded aluminum framing around the entrance. In its contrast with the dark panels it adds a vibrance and vitality to the simple Deco facade.

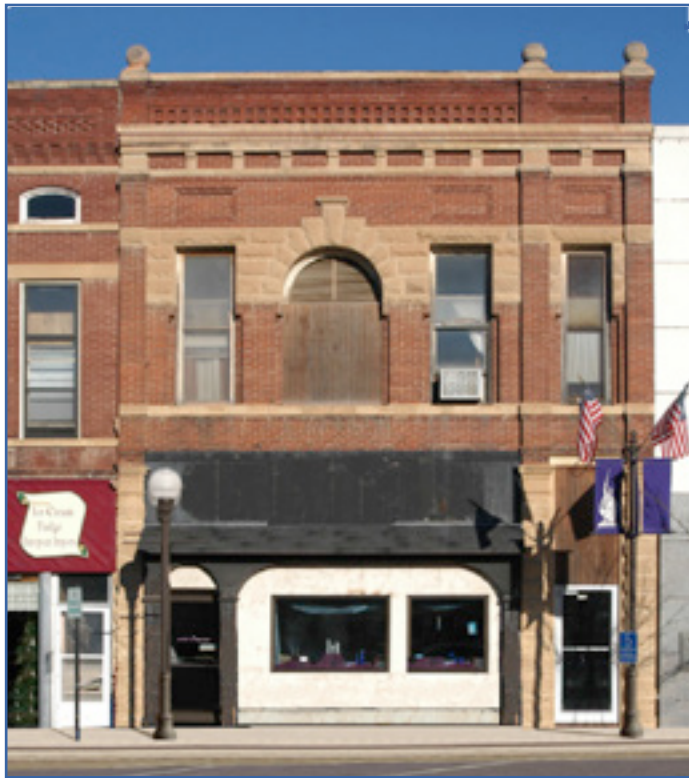
The storefront windows have been downsized and the doors do not match.

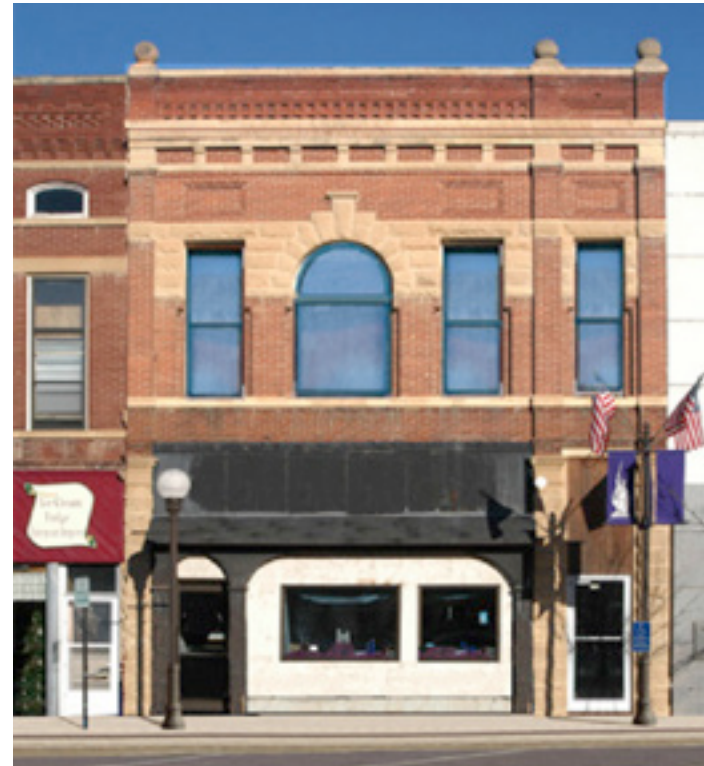
Repair, clean and repaint the upper story double hung windows.

Uncover, renovate and/or replace the upper story arched window.

Repair and tuckpoint the brick as necessary.

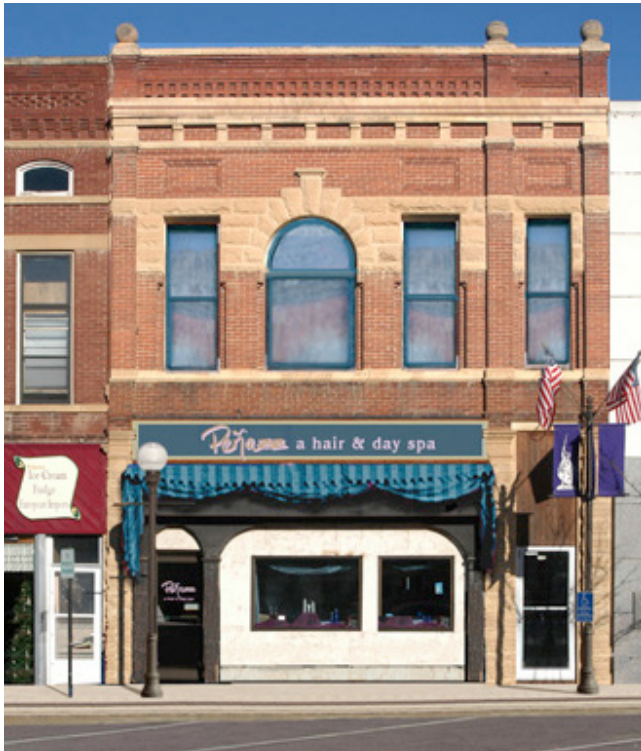
Phase 2

Apply appropriate signage on a flush signboard above the storefront.
Hang a retractable canvas awning over the storefront bay.

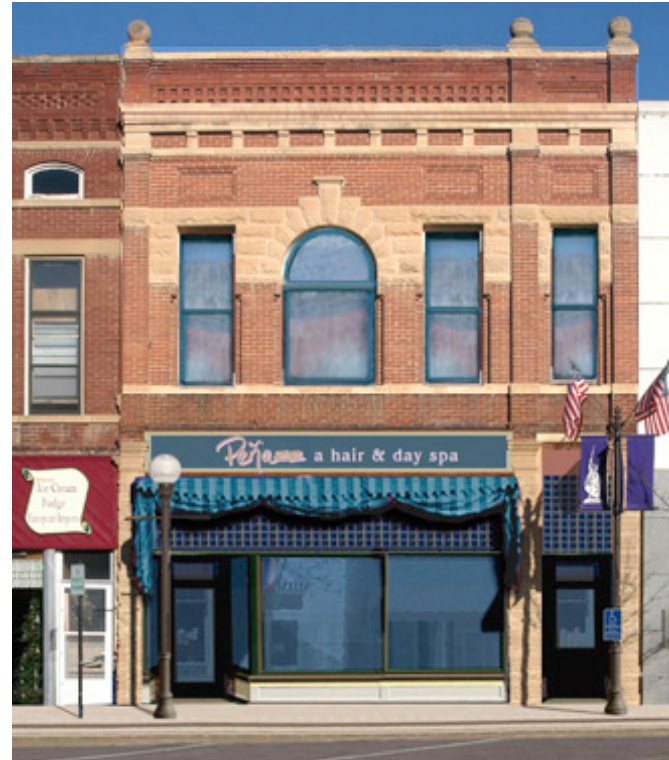
Phase 3

Rebuild storefronts as originally designed with large display windows with transom above and a bulkhead below.
Also, replace the side entry bay with an appropriate, complementary door with transom.
