Trowbridge Park Band Shell (Grand Stand) in Waseca, MN

October 1, 2009

Background

Current Project

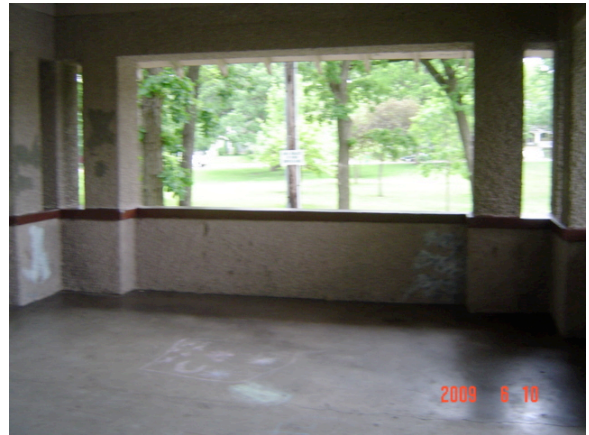
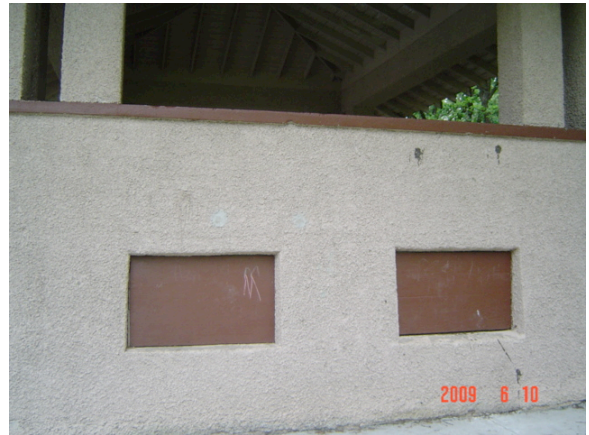
Interior Rafters

The rafters are rotting at the edge of the roof. Fixes include stubbing in rafters to keep those that are rotting strong. This would be a visually poor option. If the open ceiling and underside of the eaves were covered with wainscoting and fascia added on the end of the eaves it would be more visually appealing. Then the question is would that be proper for restoring and maintaining the integrity of the structure? Wainscoting is already in use inside about the openings.

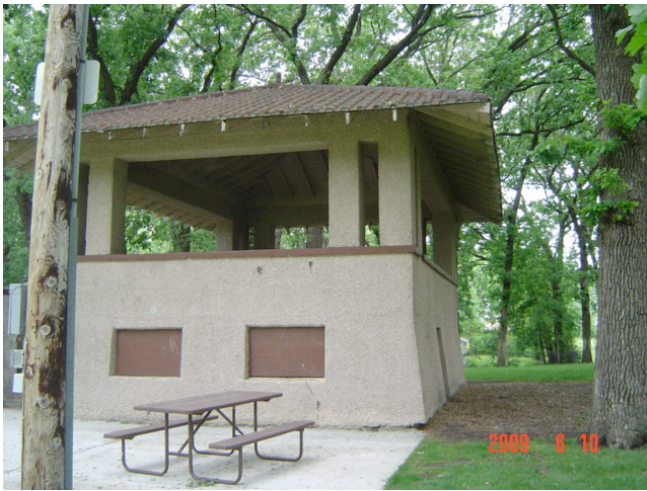
There are currently no lights or electricity in the structure itself. There is a power pole about 20' to the south of the band shell with a security light and electrical box. The power pole can be removed (which would be desirable), but security lighting and electricity would need to be added to the band shell.

Left: Note Power Pole on left in picture

If the rafters are covered with wainscoting, surface mounted recessed lighting could be added easily inside the band shell and on the outside corners for visibility and security. Use of motion detectors with lights would add to security so the lights would not have to remain on all night. Electrical outlets in secure locked boxes could be added inside behind the 3' walls and in the lower level.

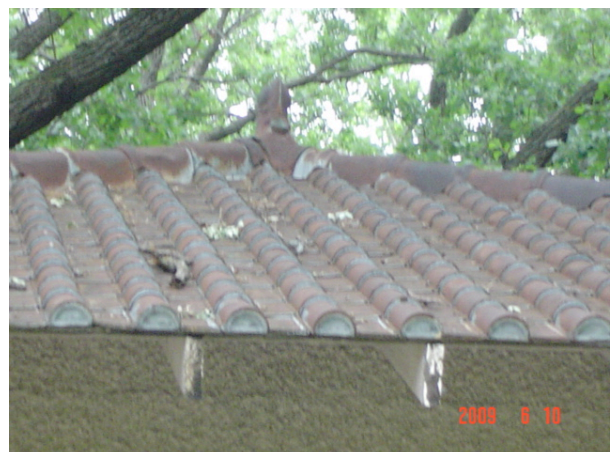
The best we can tell the roof is original – tin – and in reasonably good condition. Nothing is planned for the roof.
